Structural Assessment

**First United Methodist Church
319 LaReine Avenue
Bradley Beach, NJ 07720**

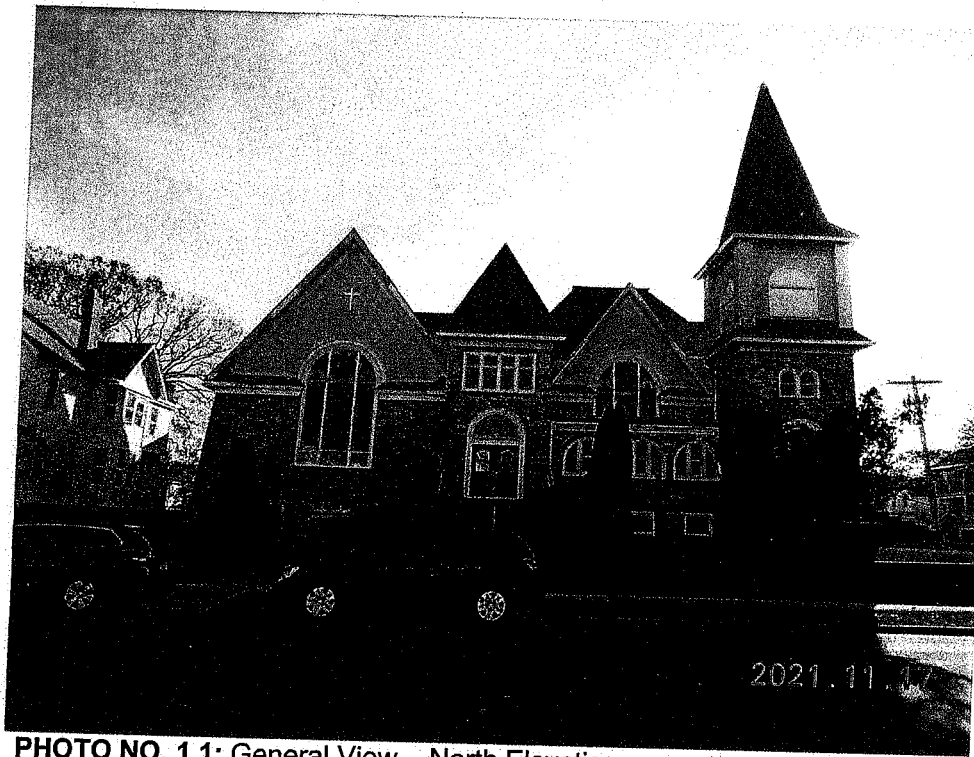
PHOTO NO. 1.1: General View – North Elevation

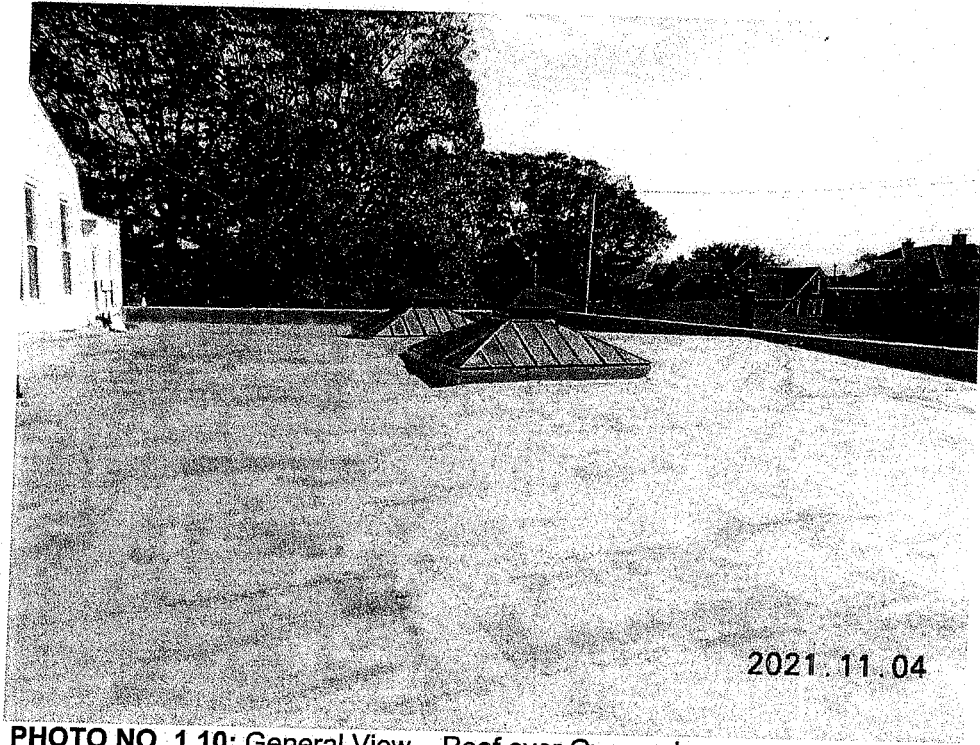
PHOTO NO. 1.10: General View – Roof over Gymnasium

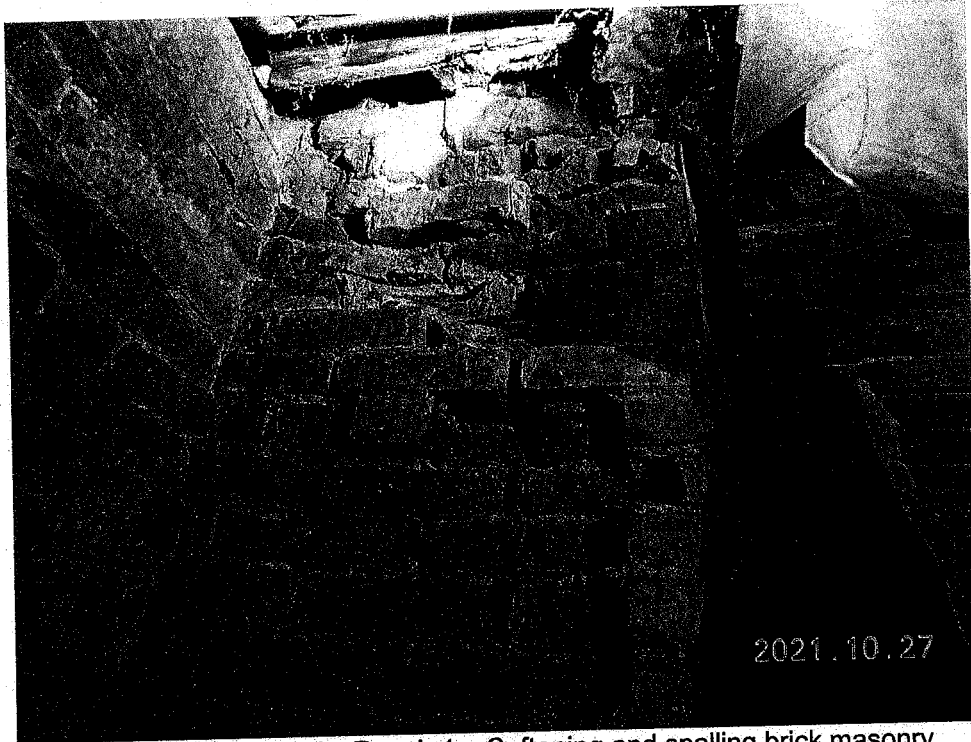
PHOTO NO. 1.11: Priority Repair 1 – Softening and spalling brick masonry foundation with deteriorated mortar joints – Lower Level, Grid A/2-7

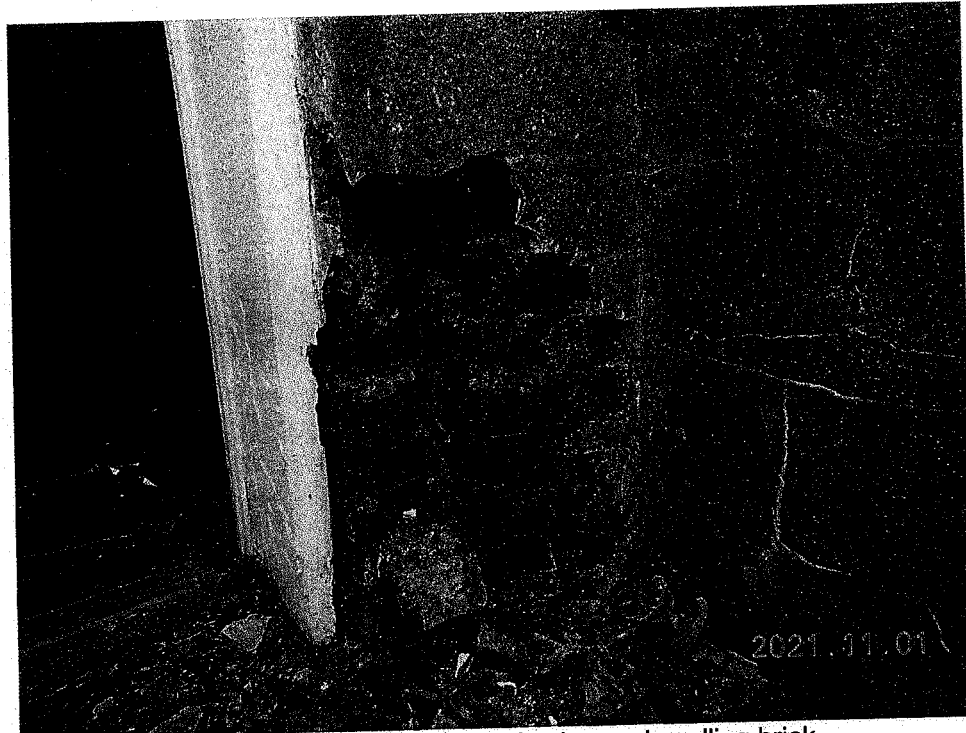
PHOTO NO. 1.12: Priority Repair 1 - Softening and spalling brick masonry foundation with deteriorated mortar joints and spalling parge coat – Lower Level, Grid A/2-7

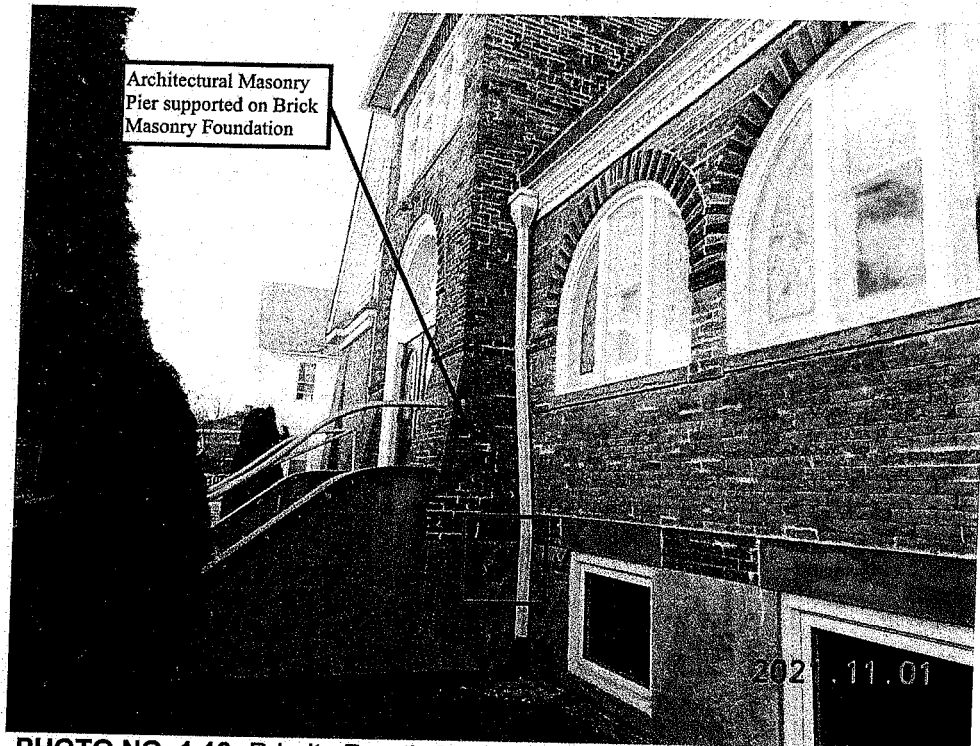
PHOTO NO. 1.13: Priority Repair 2 – Overall view of unraveling brick masonry piers with spalling parge coat, deteriorated / washed out mortar joints and softening clay bricks – North Elevation, Grid 5: El. 6' +/-

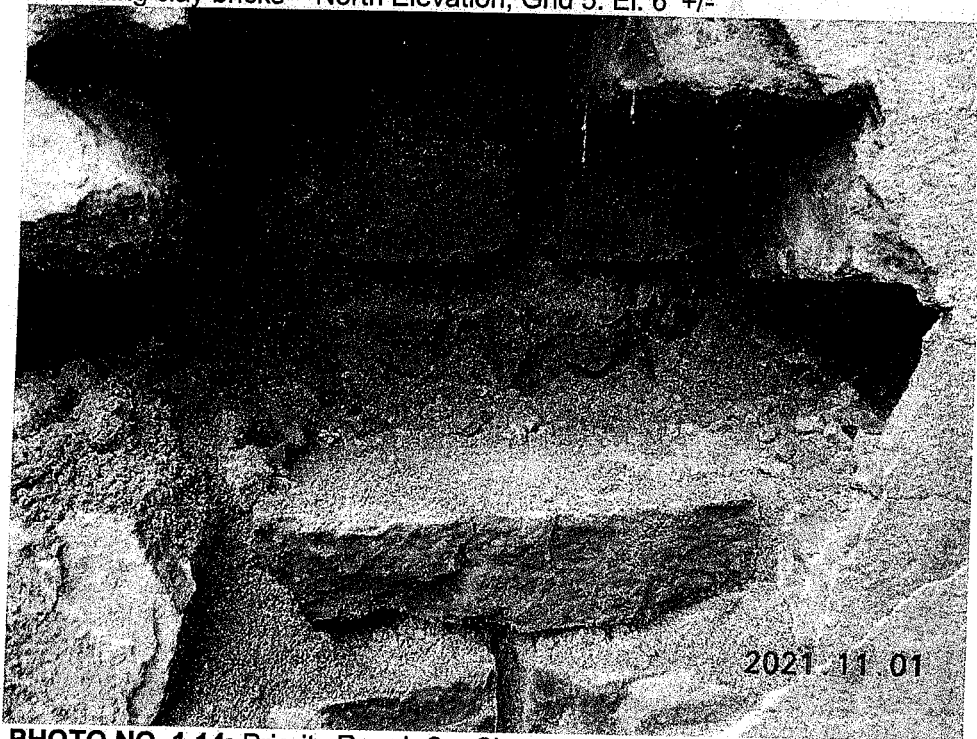
PHOTO NO. 1.14: Priority Repair 2 – Close-up view of severely damaged brick masonry piers. Note: condition of interior wythe bricks and mortar – North Elevation, Grid 5: El. 6' +/-

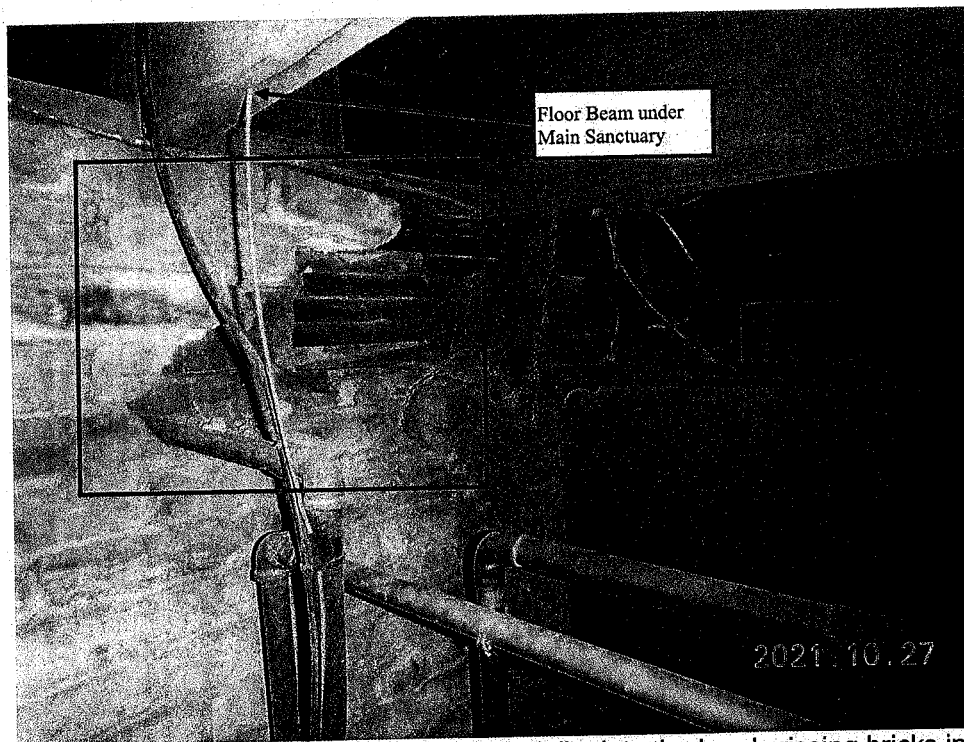
PHOTO NO. 1.15: Priority Repair 3 – Partially detached and missing bricks in load bearing interior wall – Lower Level, Grid B/5

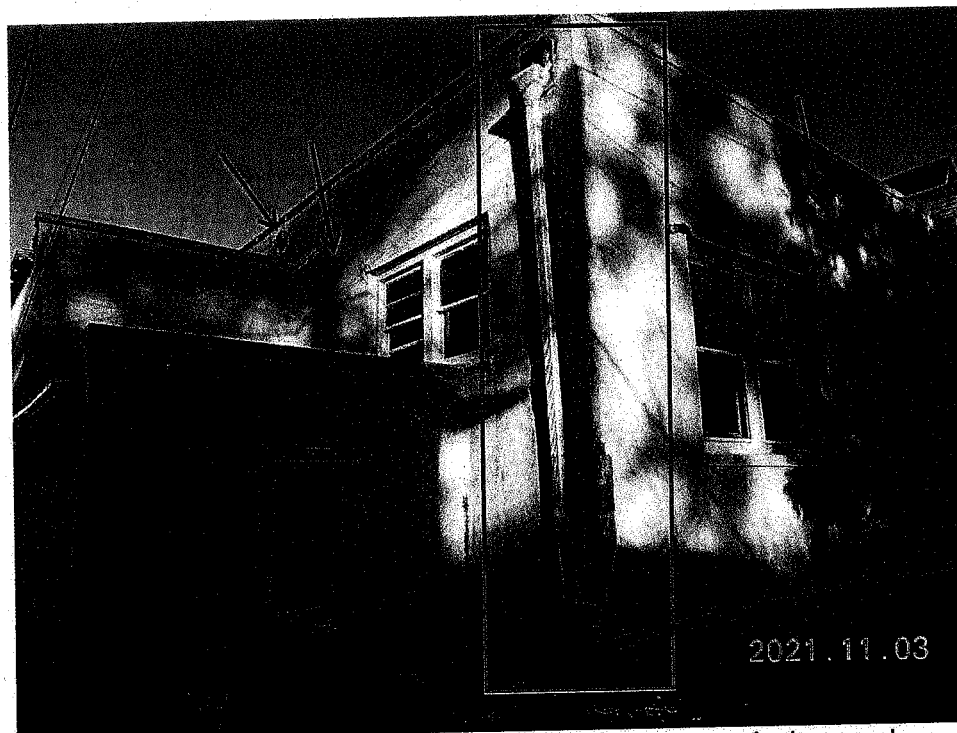
PHOTO NO. 1.16: Priority Repair 4 – Overall view of severely damaged cinder block exterior walls of the Gymnasium consisting of wide vertical cracking, spalling, and softening – South & East Elevations

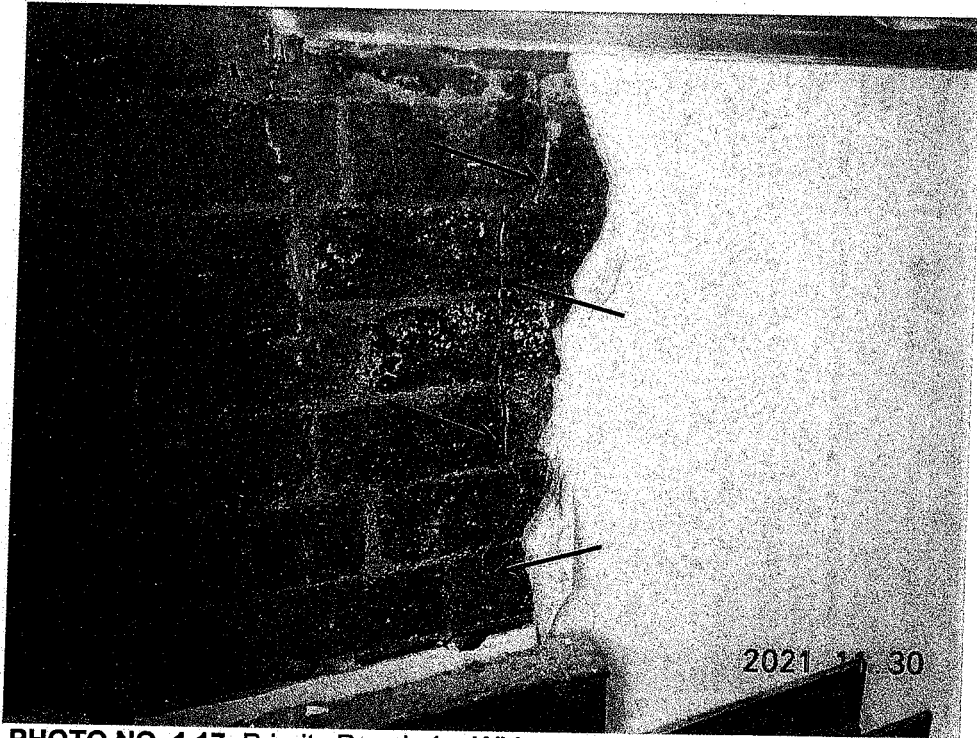
PHOTO NO. 1.17: Priority Repair 4 – Wide vertical crack in unreinforced cinder block wall of the Gymnasium – South Elevation, Grid 1-5: El. 0'-20'+/-

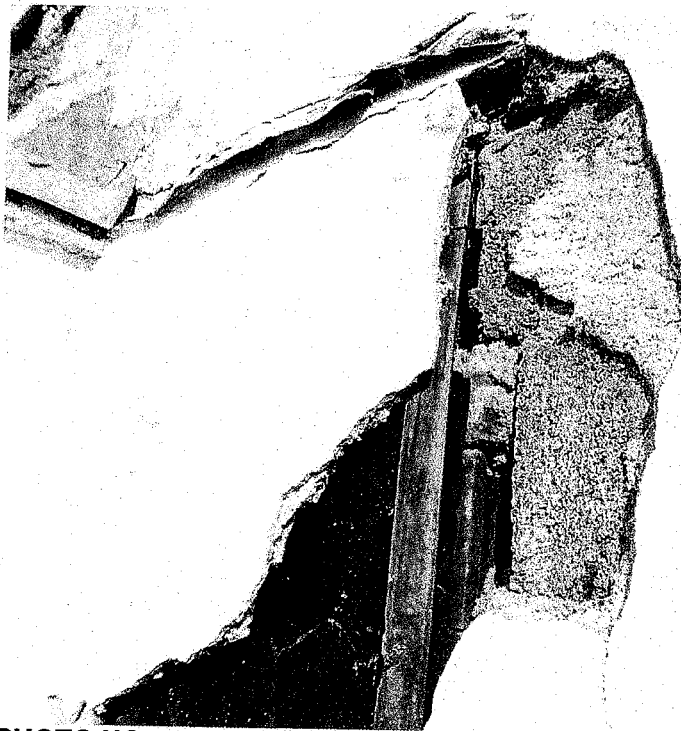
PHOTO NO. 1.18: Priority Repair 4 – Bulging and spalling of parge coat behind steel column position – South Elevation, Grid 1-5: El. 0'-20' +/-

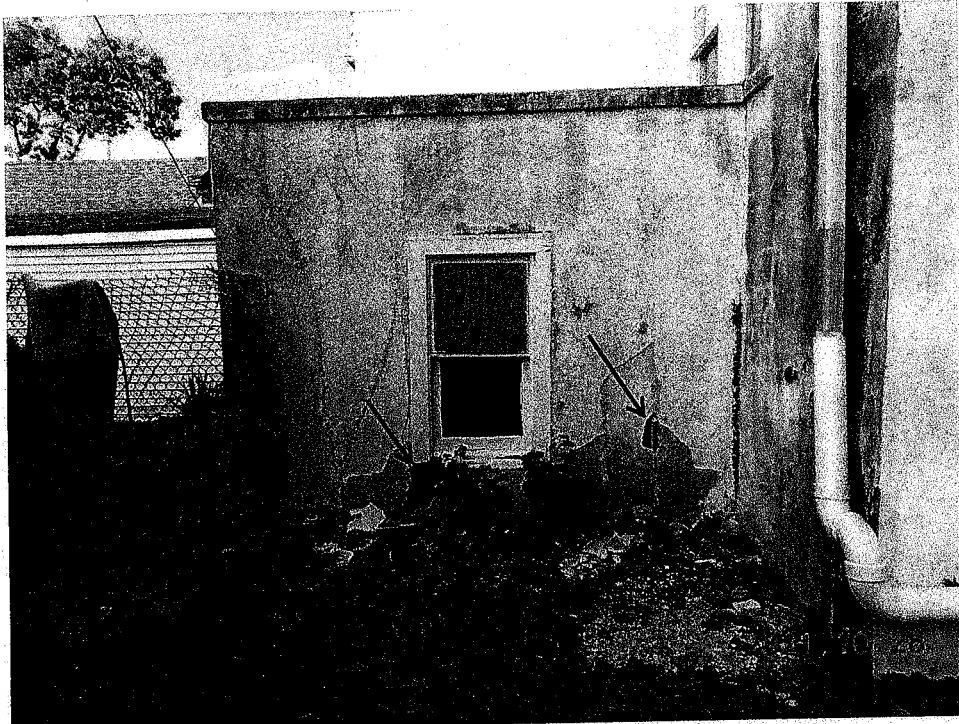
PHOTO NO. 1.19: Priority Repair 5 – Spalled plaster with wire lathe façade over rotting timber wall framing – East Elevation, Grid H-I: El. 6' +/-

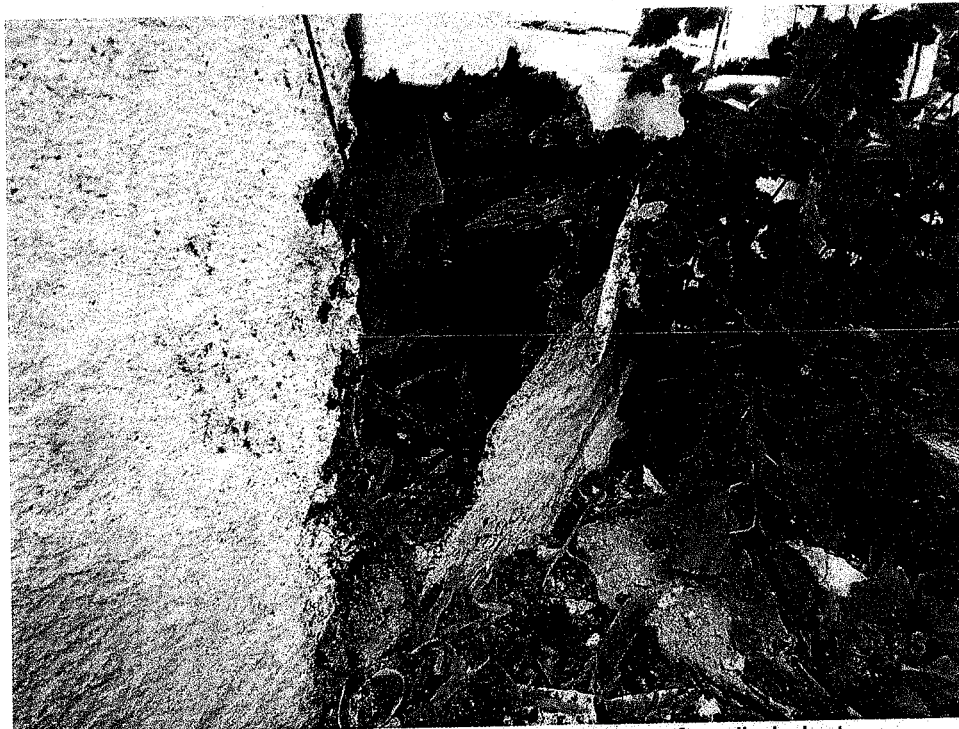
PHOTO NO. 1.20: Priority Repair 5 – Close-up view of spalled plaster with wire lathe façade over rotting timber wall framing – East Elevation, Grid H-I: El. 6' +/-

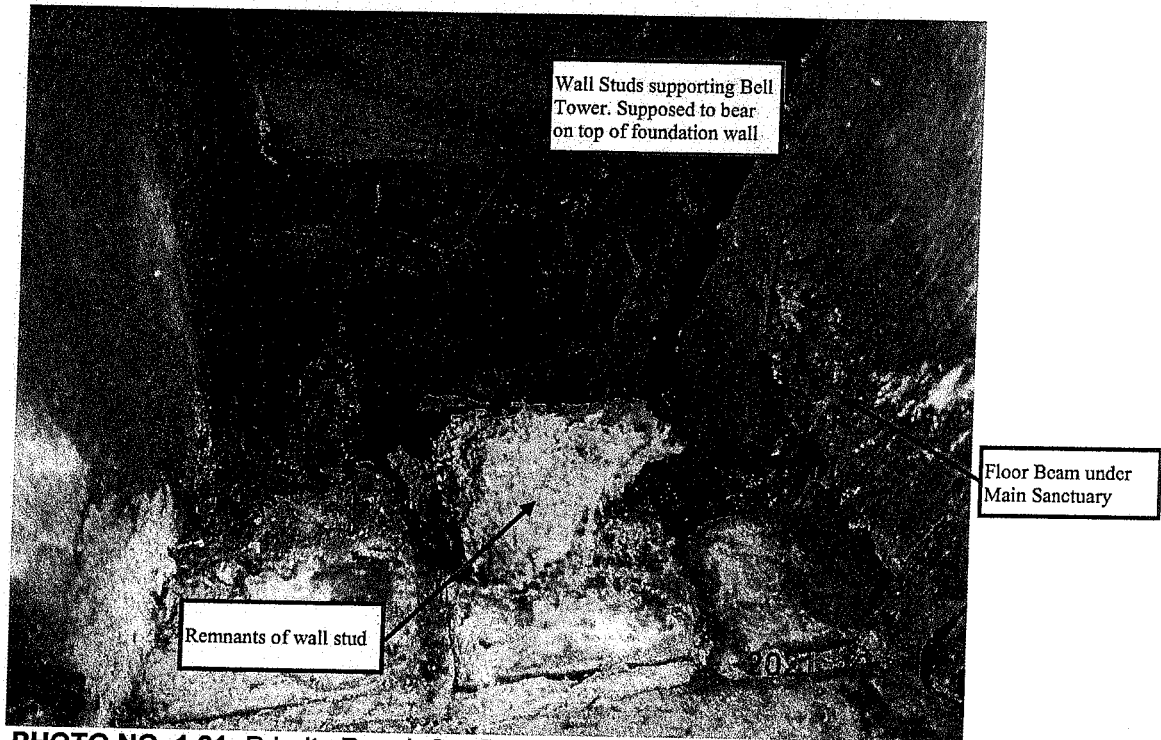
PHOTO NO. 1.21: Priority Repair 6 – Severe deterioration, up to 100% sections loss, at the base of timber wall studs supporting the Bell Tower and floor framing for lower level – Lower Level, Grid A/6-7

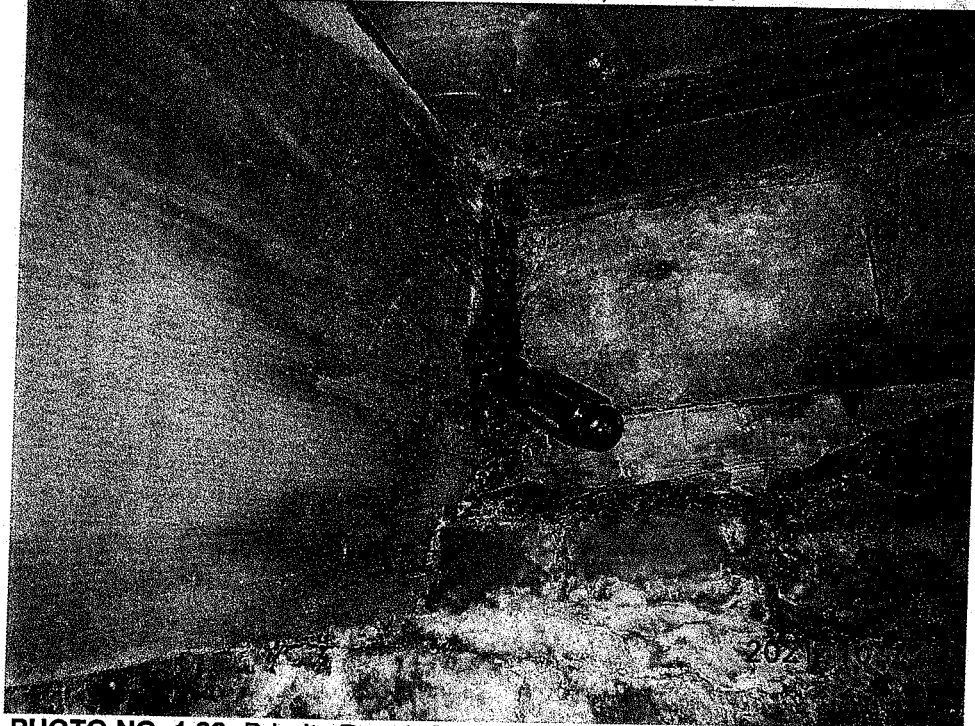
PHOTO NO. 1.22: Priority Repair 6 – Rotting and soft timber floor beam at bearing ends due to active water infiltration – Sanctuary Framing, Grid A/6-7

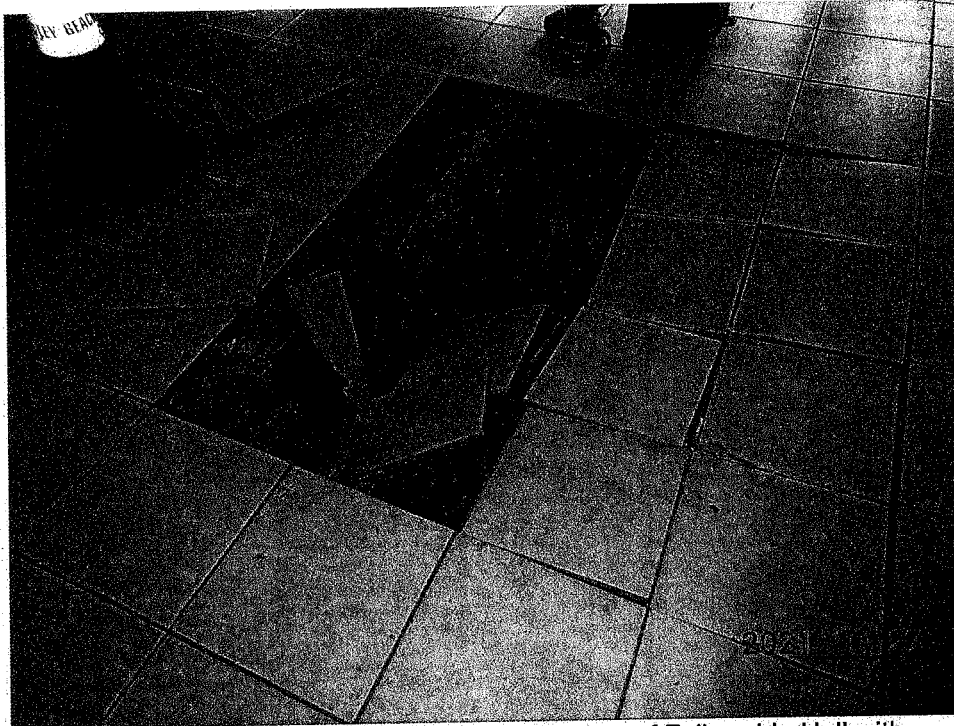
PHOTO NO. 1.23: Priority Repair 7 – Overall view of Fellowship Hall with failing floor system due to severely deteriorated timber stringers and subfloor – Lower Level, Grid A-E/2-4

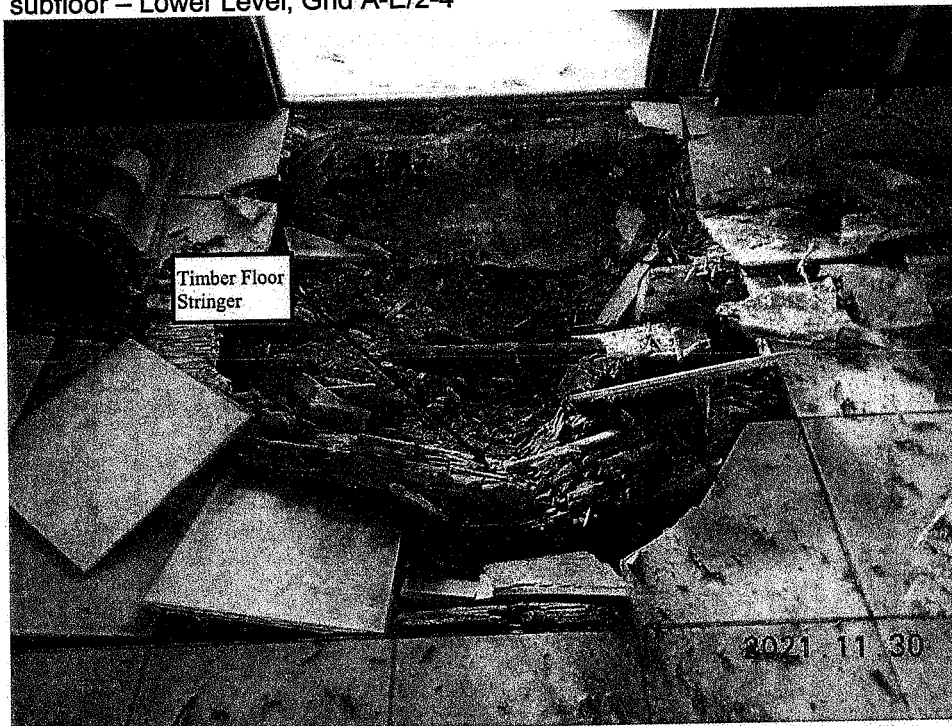
PHOTO NO. 1.24: Priority Repair 7 – Overall view of Fellowship Hall with failing floor system due to severely deteriorated timber stringers and subfloor – Lower Level, Grid A-E/2-4

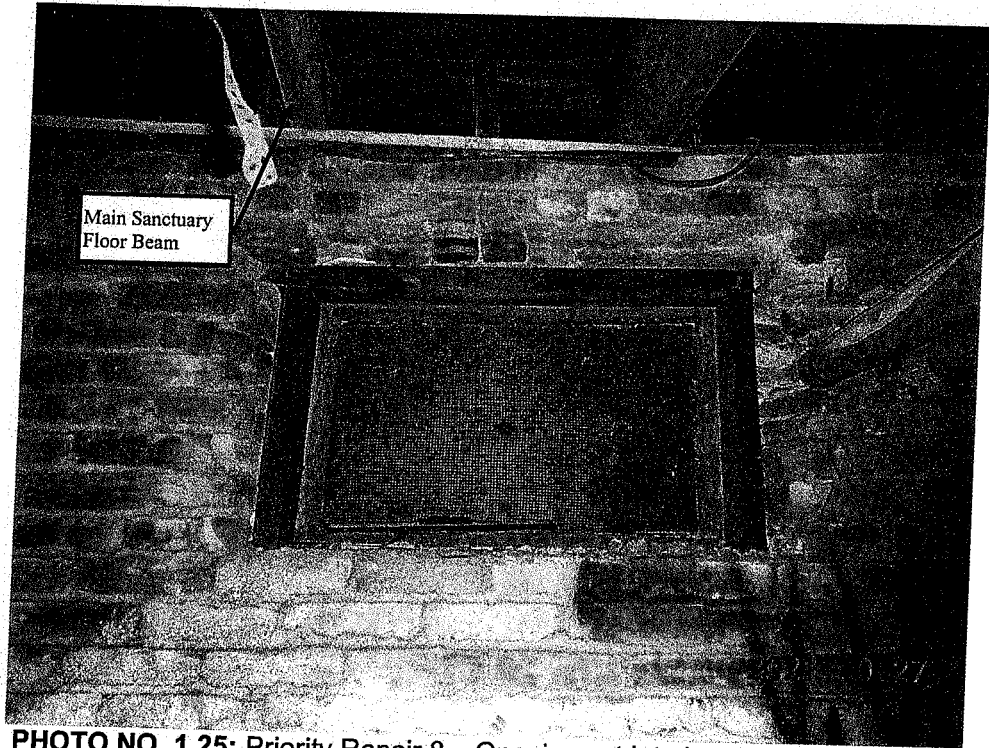
PHOTO NO. 1.25: Priority Repair 8 – Opening cut into load bearing brick masonry wall with no lintel – Lower Level, Grid B/6

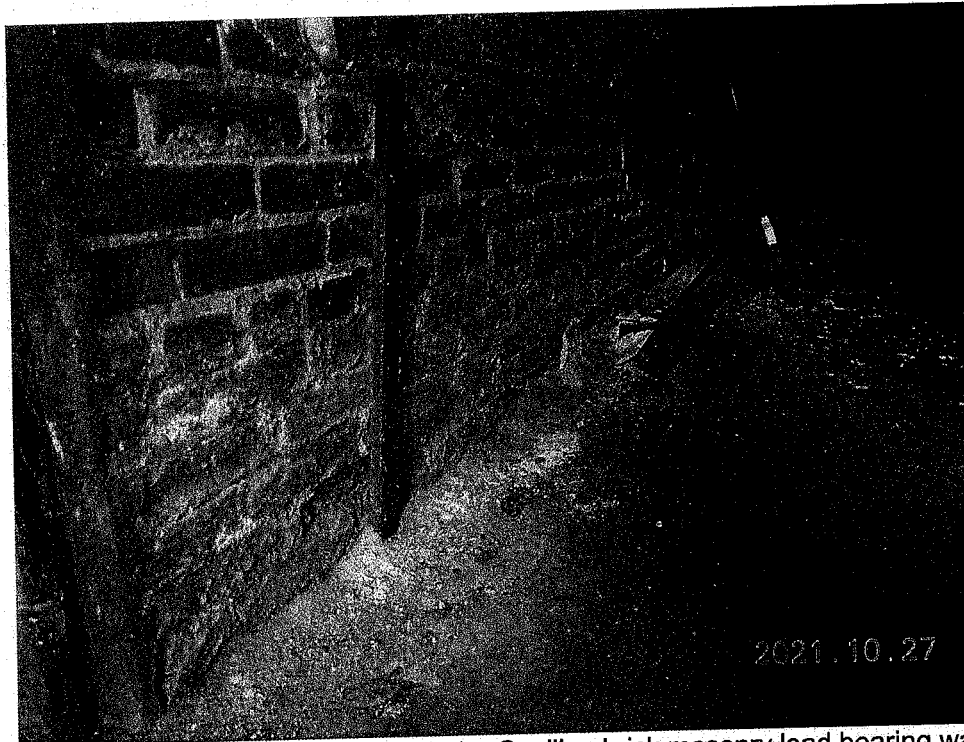
PHOTO NO. 1.26: Routine Repair 1 – Spalling brick masonry load bearing wall with deteriorated mortar joints – Lower Level, Grid B/5-7

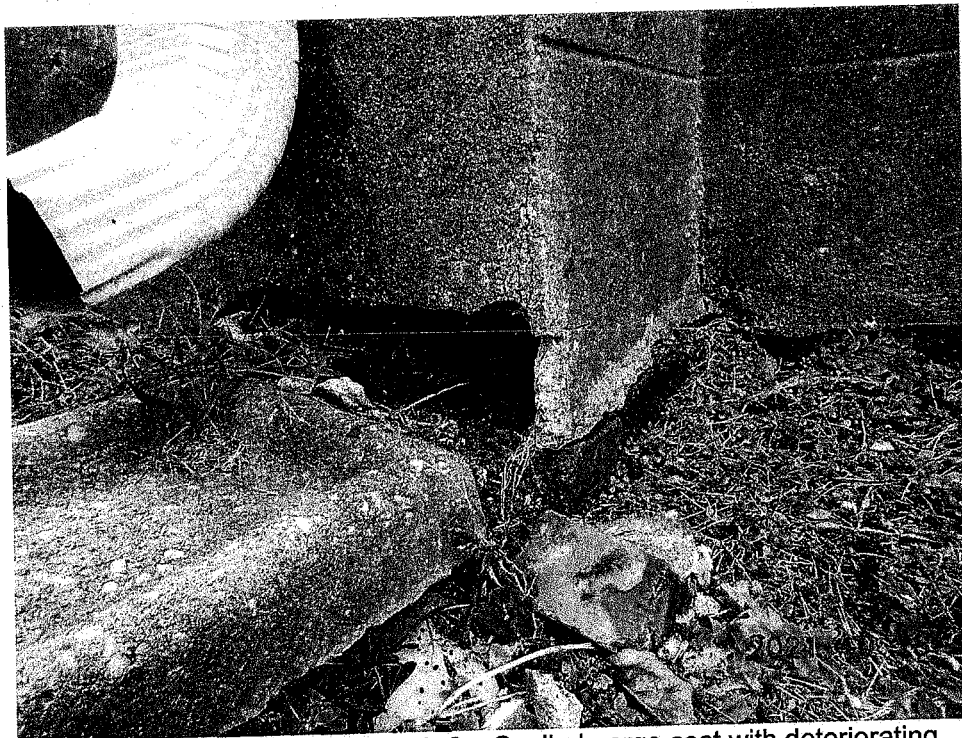
PHOTO NO. 1.27: Routine Repair 2 – Spalled parge coat with deteriorating brick masonry foundation wall – East Elevation, Grid C: Ht. 0' +/-

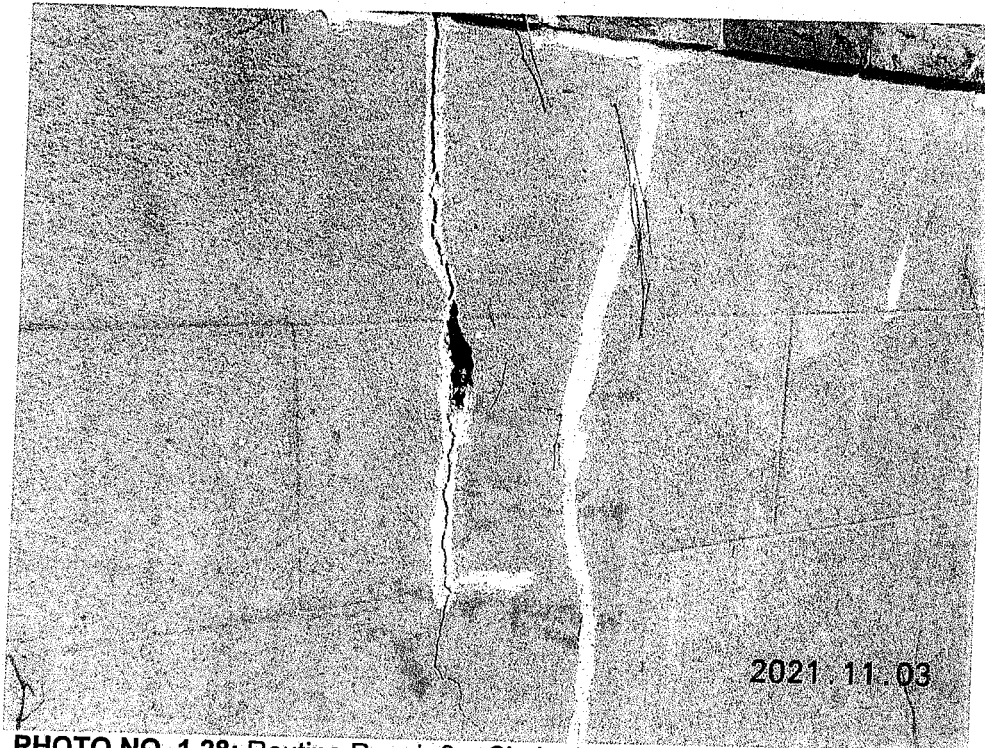
PHOTO NO. 1.28: Routine Repair 3 – Cinder block exterior wall with parge coat
– South Elevation, Grid 5-6: Ht. 6' +/-

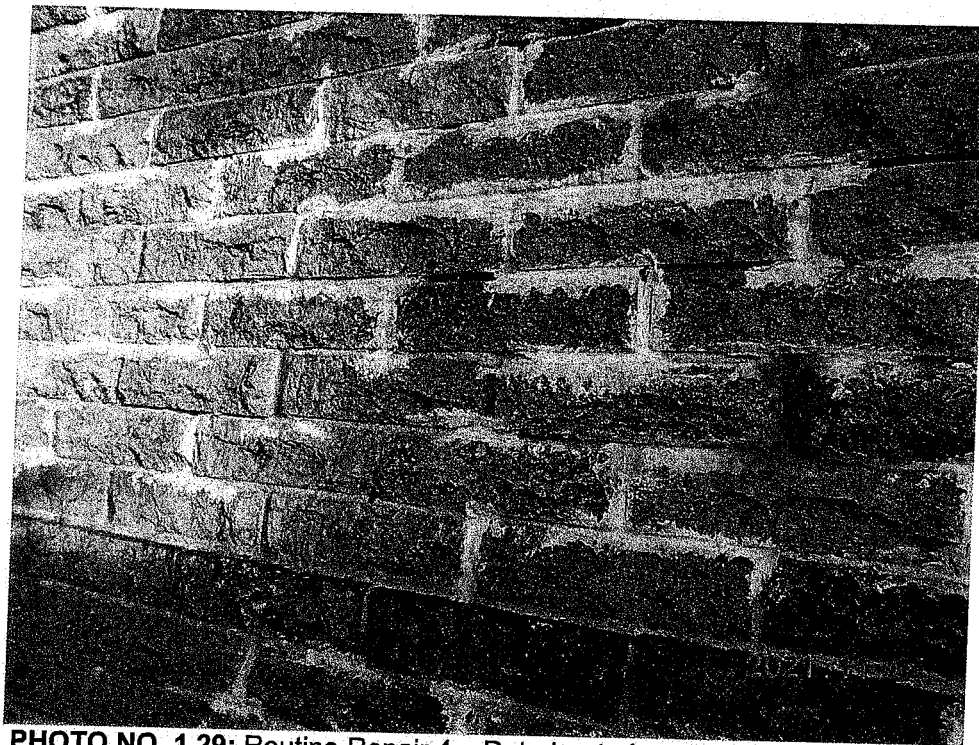
PHOTO NO. 1.29: Routine Repair 4 – Deteriorated mortar joints and
joints filled with caulk and silicone in brick masonry facade – South
Elevation, Grid 5-6: Ht. 6'-12' +/-

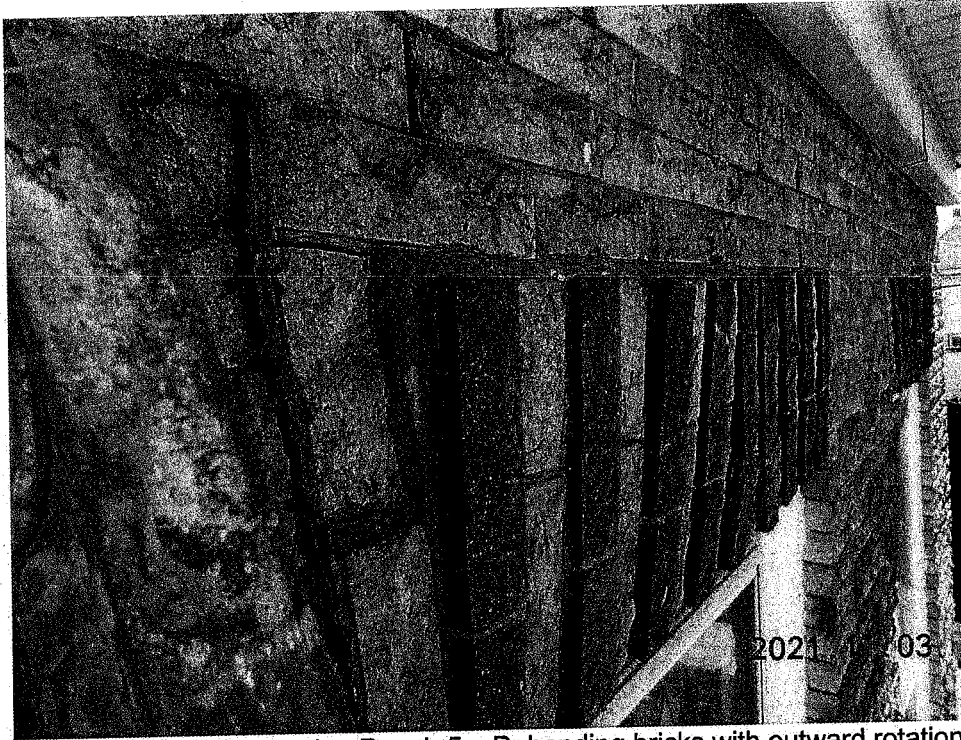
PHOTO NO. 1.30: Routine Repair 5 – Debonding bricks with outward rotation in brick masonry header – West Elevation, Grid E-F (north): Ht. 20' +/-

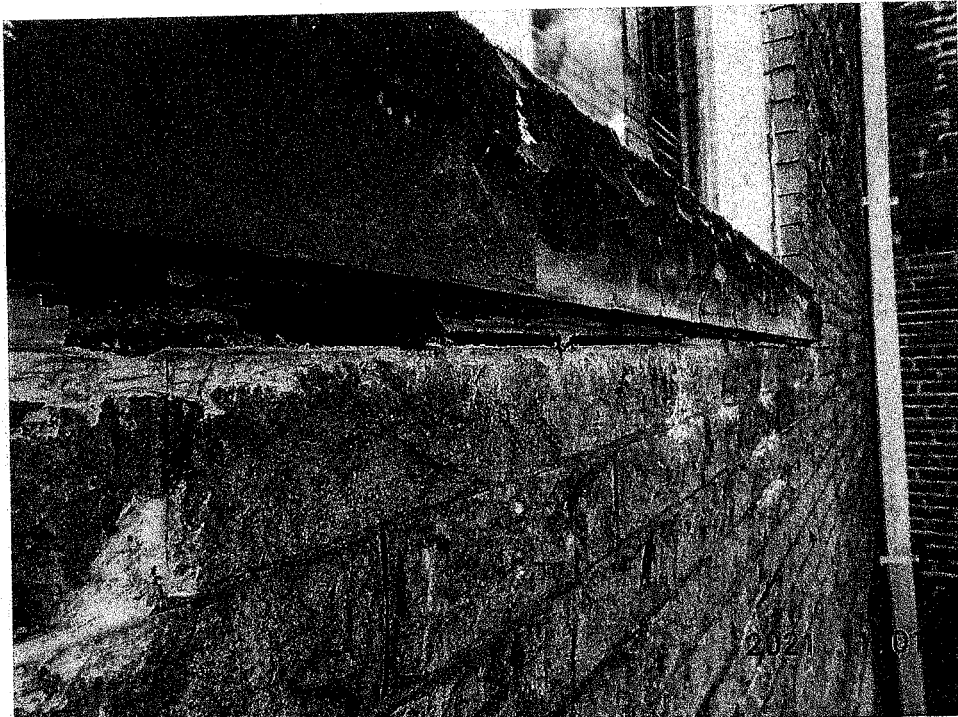
PHOTO NO. 1.31: Routine Repair 6 – Deteriorated mortar joint under stone masonry windowsill. Sill is back pitched. – North Elevation, Grid 3: Ht. 10'

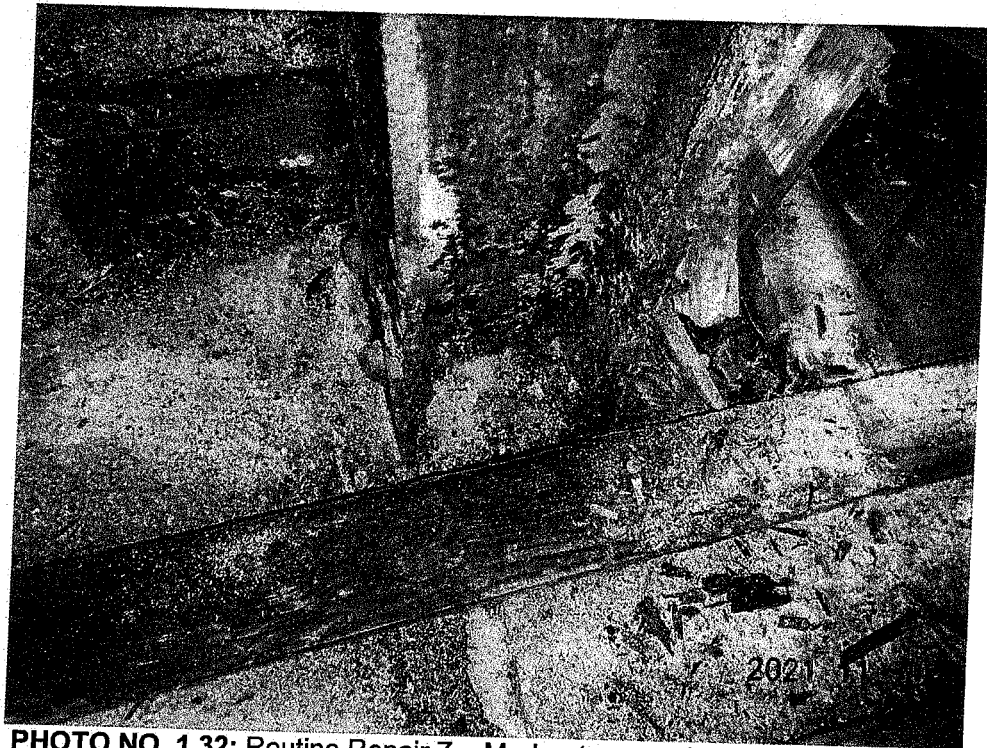
PHOTO NO. 1.32: Routine Repair 7 – Moderate corrosion of steel column
– Lower Level, Grid F/4

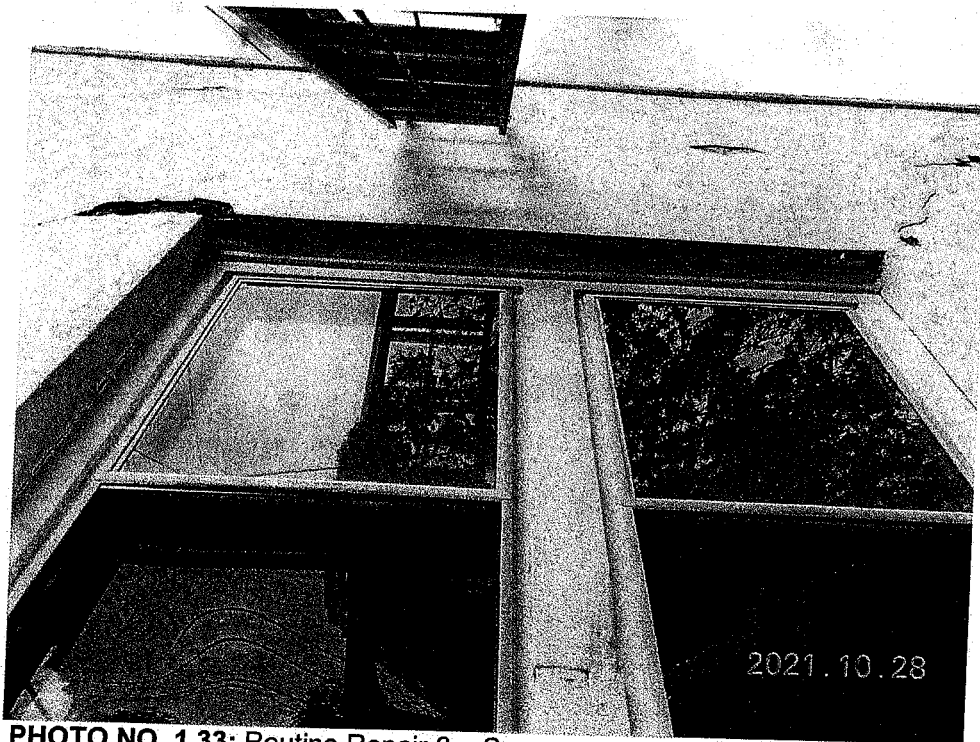
PHOTO NO. 1.33: Routine Repair 8 – Severe corrosion of steel lintel over
window opening – East Elevation, Grid G-H: Ht. 12'

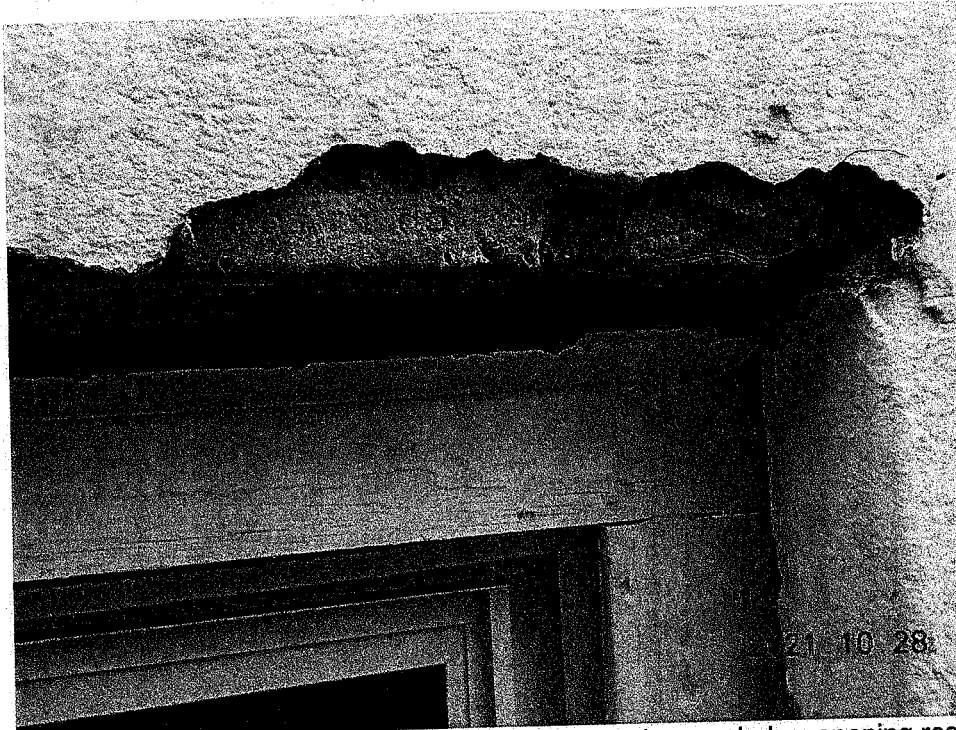
PHOTO NO. 1.34: Routine Repair 9 – Missing lintel over window opening resulting in unsupported brick masonry – East Elevation, Grid E-F (south): Ht. 13' +/-

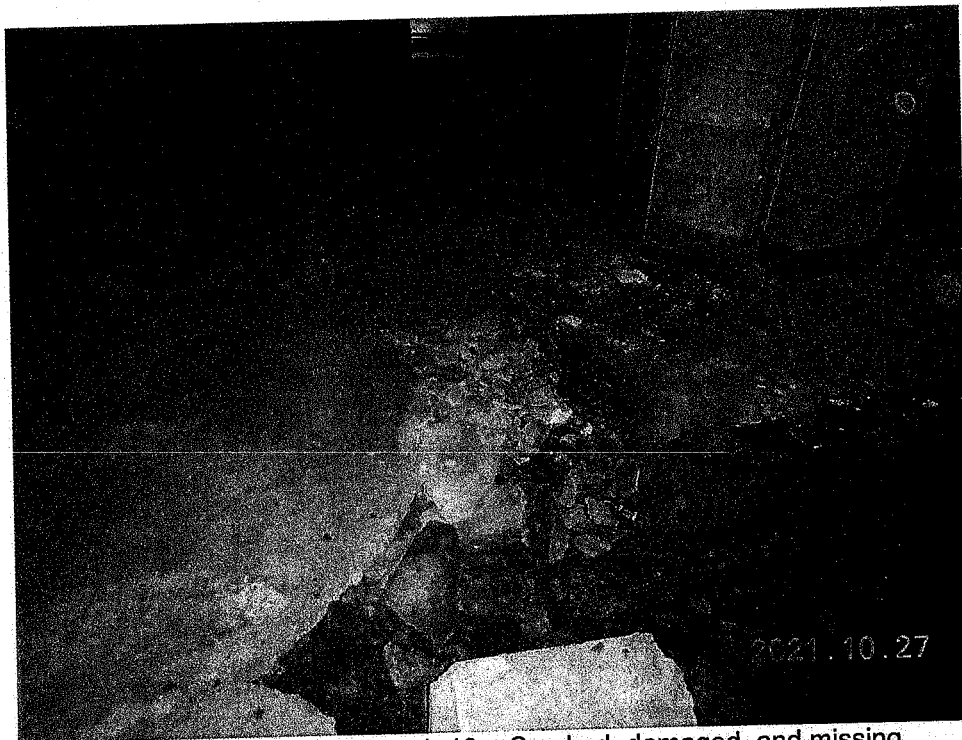
PHOTO NO. 1.35: Routine Repair 10 – Cracked, damaged, and missing concrete floor slab – Lower Level, Grid B-D/4-6

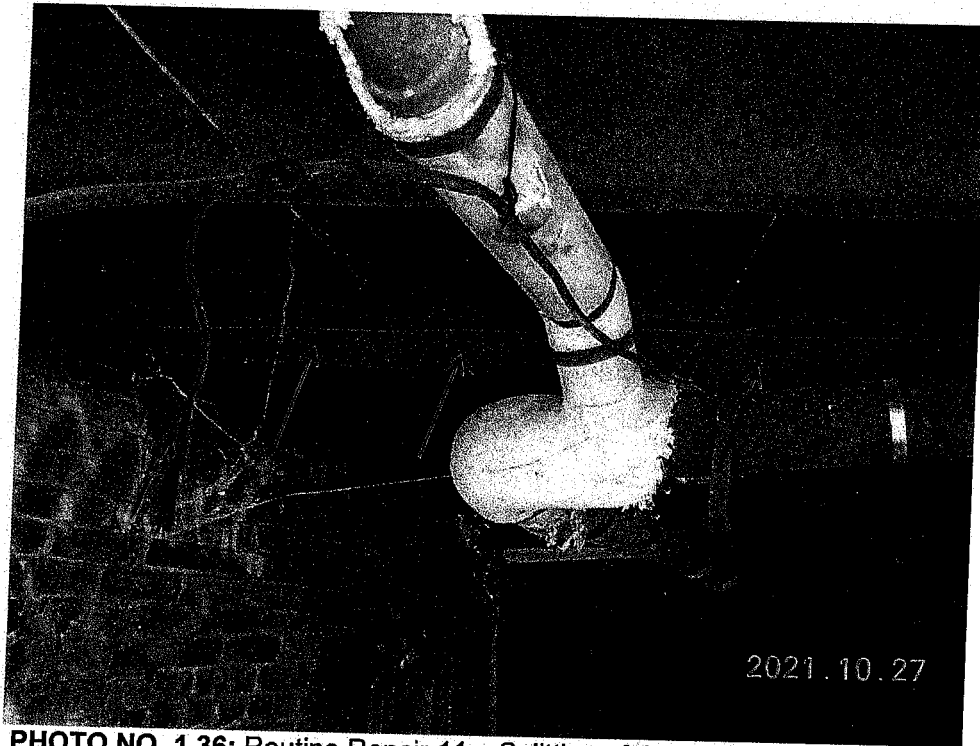
PHOTO NO. 1.36: Routine Repair 11 – Splitting of timber floor beam under Main Sanctuary – Sanctuary Framing, Grid B-D/5-7

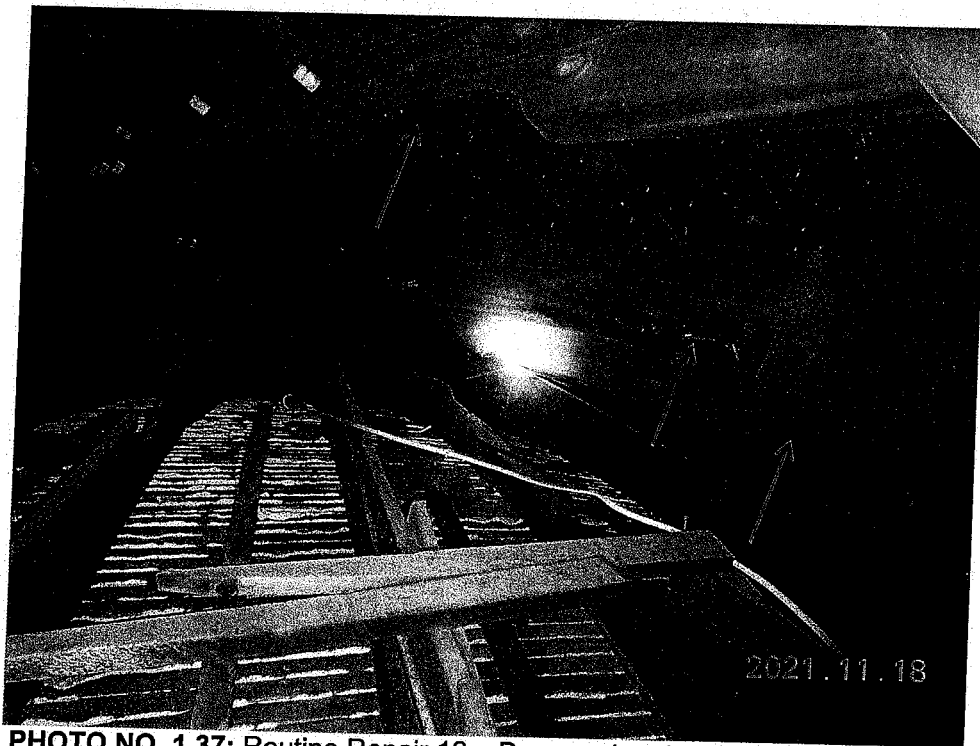
PHOTO NO. 1.37: Routine Repair 12 – Damaged and notched timber roof beams – Roof, Grid B-C/4-5

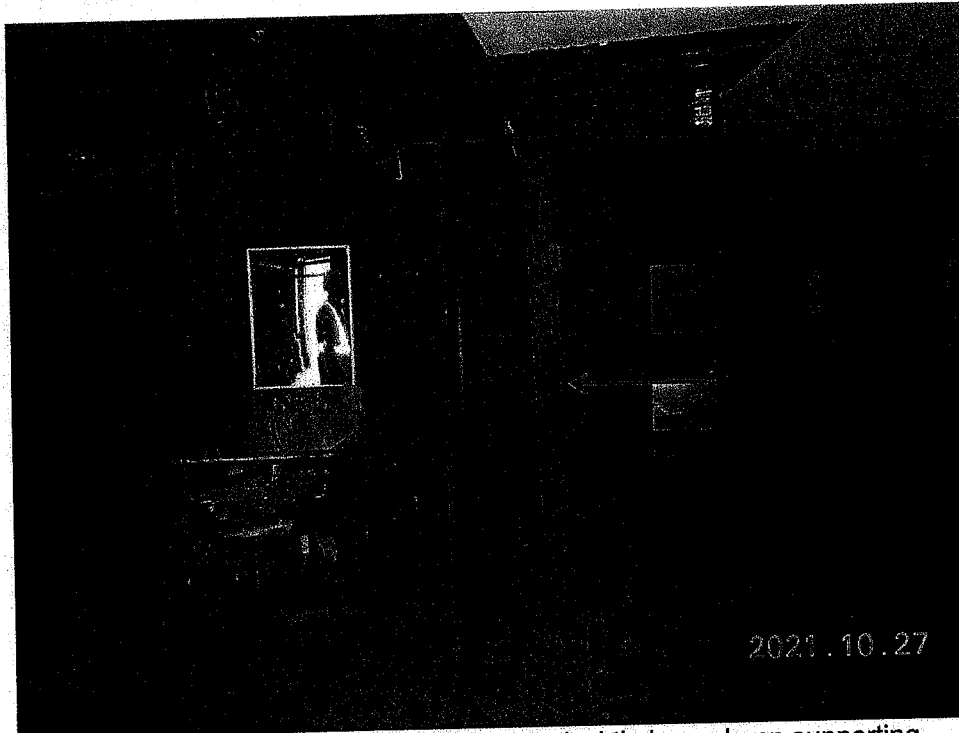
PHOTO NO. 1.38: Routine Repair 13 – Atypical timber column supporting girder inconsistent with adjacent steel column – Lower Level, Grid C-D/5
