Structural Assessment

**First United Methodist Church
319 LaReine Avenue
Bradley Beach, NJ 07720**

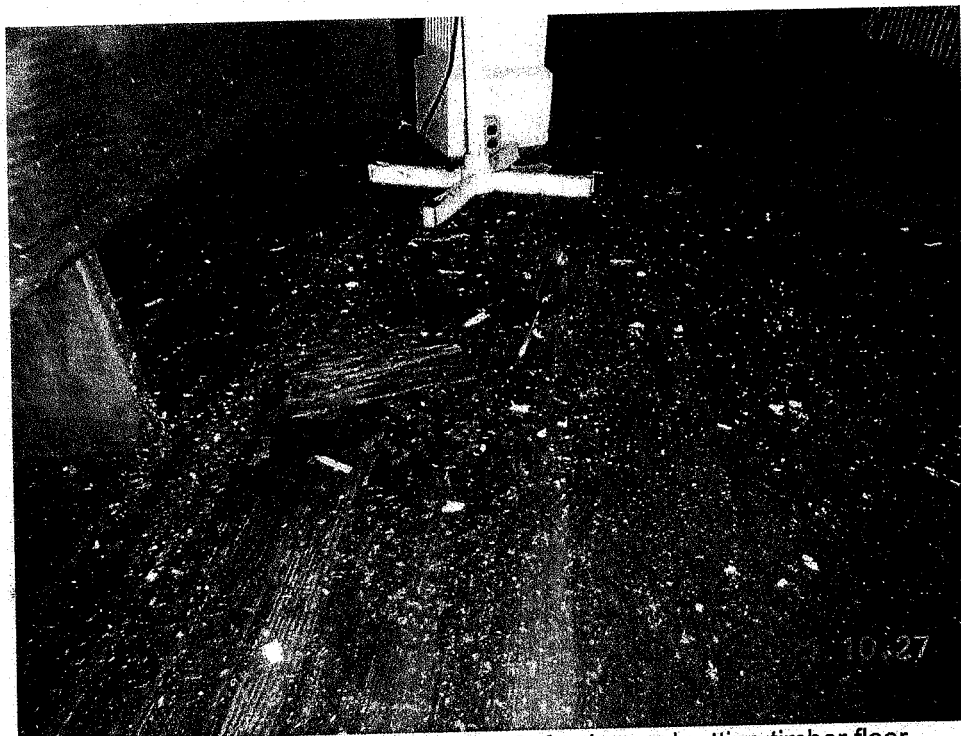
PHOTO NO. 1.39: Routine Repair 14 – Softening and rotting timber floor planks due to water infiltration from roof – Sanctuary Level, Grid B-C/5-7

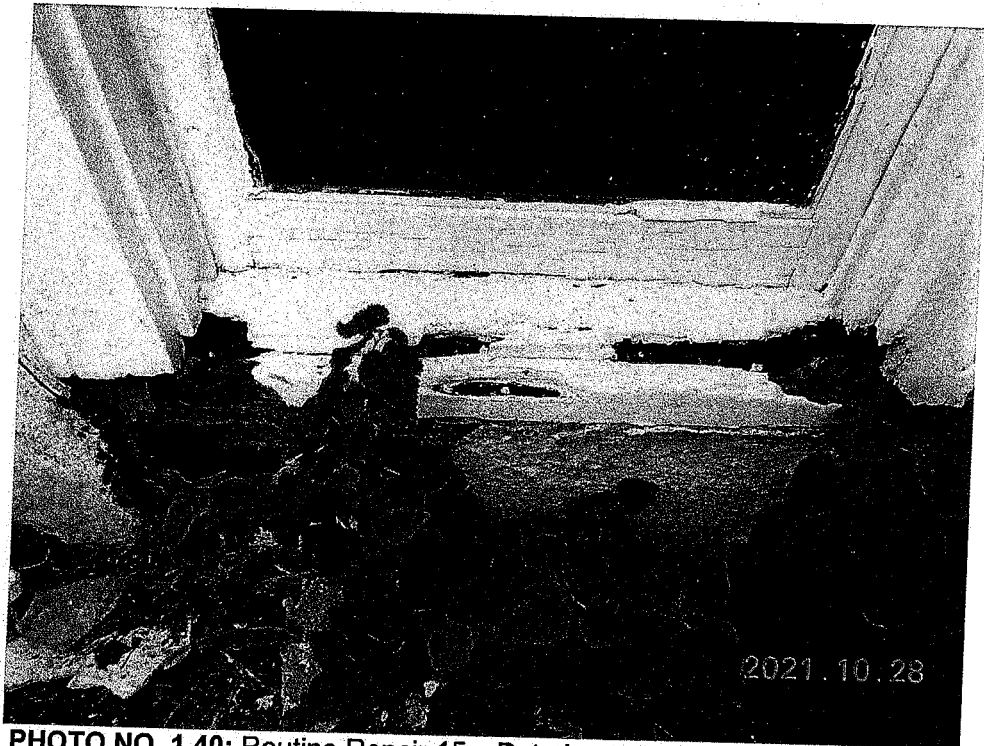
PHOTO NO. 1.40: Routine Repair 15 – Deteriorated window and timber window frame – East Elevation, Grid H-I: Ht. 3' +/-

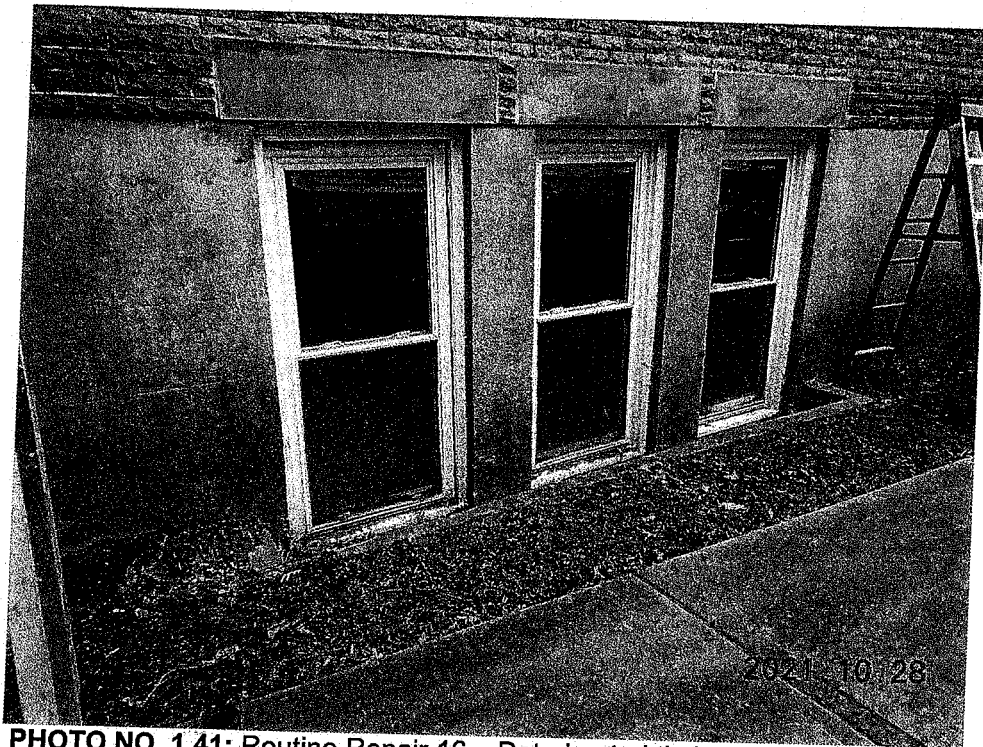
PHOTO NO. 1.41: Routine Repair 16 – Deteriorated timber window frames due to sills being located below grade – East Elevation, Grid D: Ht. 2' +/-

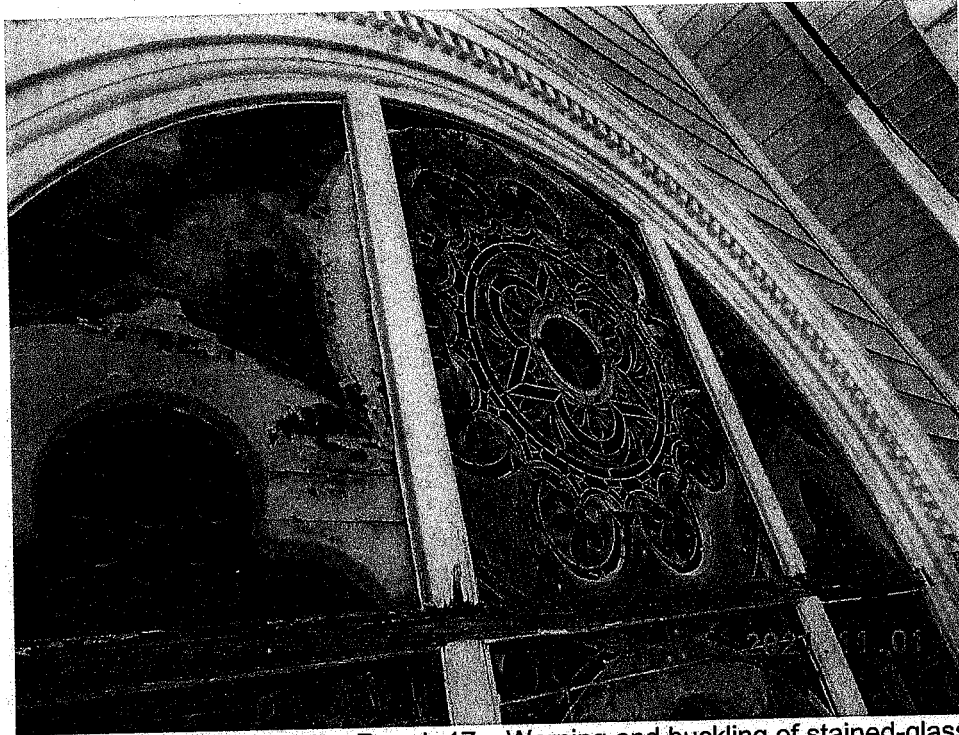
PHOTO NO. 1.42: Routine Repair 17 – Warping and buckling of stained-glass window with deteriorated timber frame – North Elevation, Grid 5-6: Ht. 25'

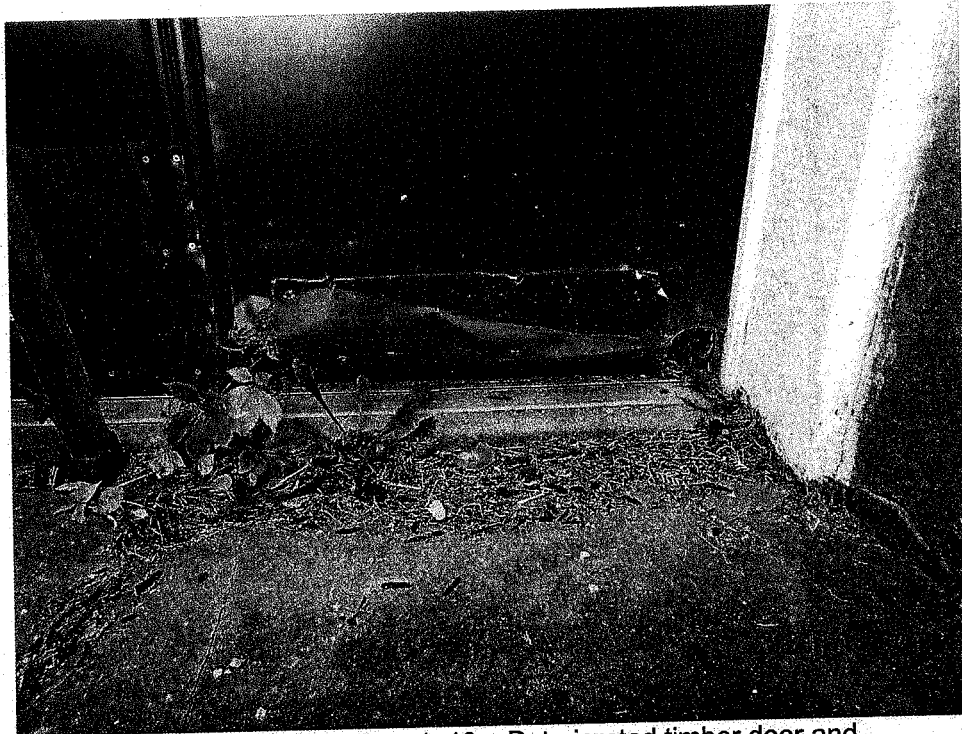
PHOTO NO. 1.43: Routine Repair 18 – Deteriorated timber door and frame – North Elevation, Grid 2-3: Ht. 0' +/-

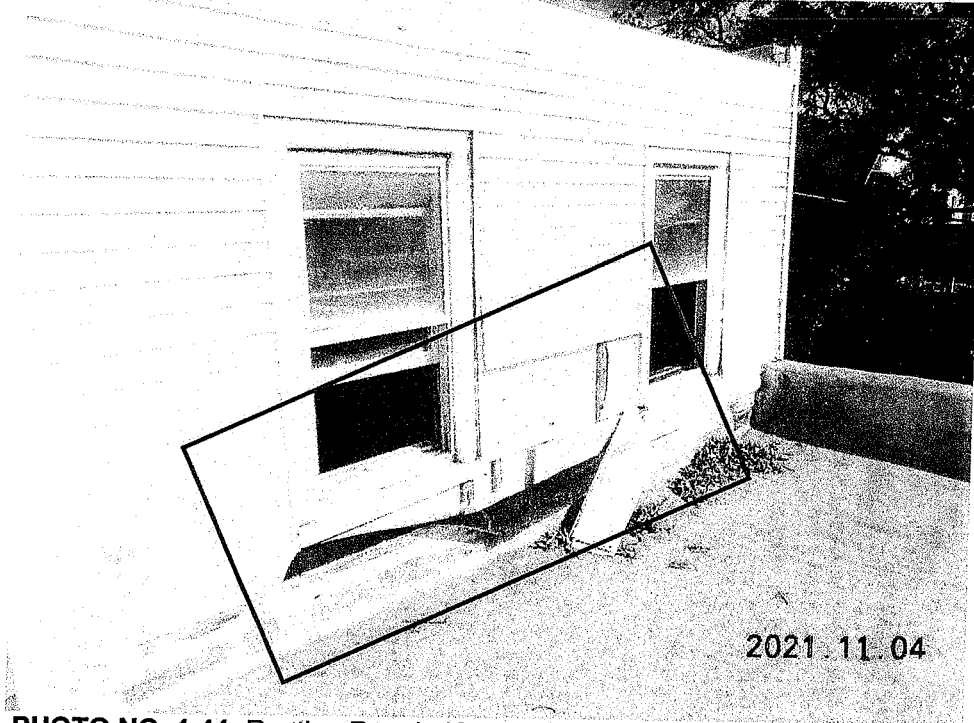
PHOTO NO. 1.44: Routine Repair 19 – Partially detached and missing vinyl siding – South Elevation, Grid 1-2: Ht. 20'+/-

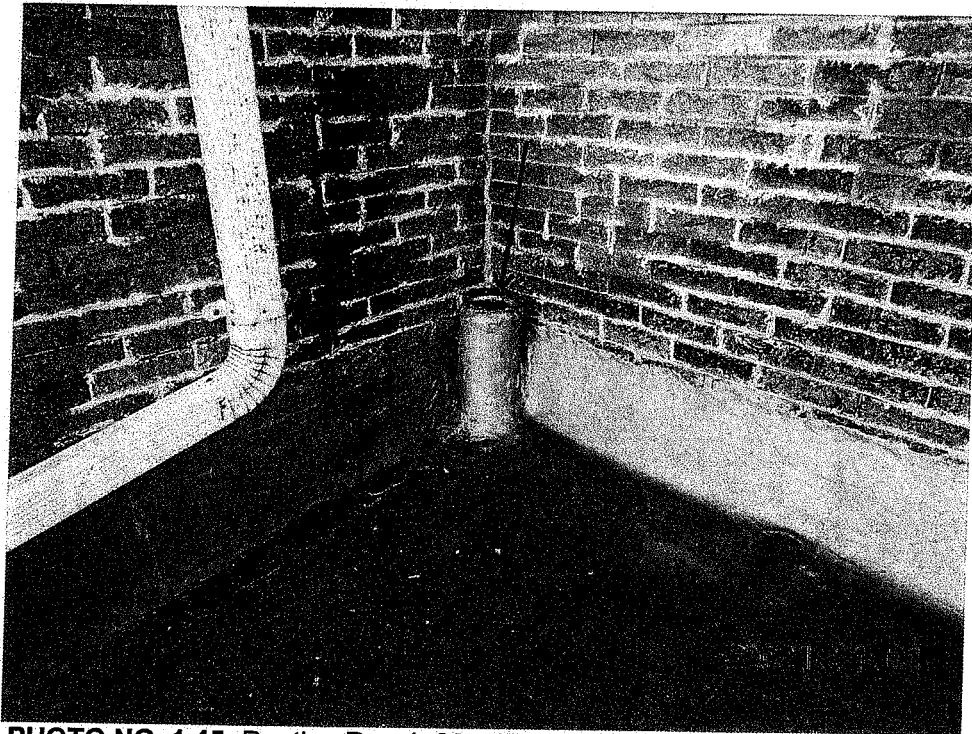
PHOTO NO. 1.45: Routine Repair 20 – Unsealed penetration in roof – Roof, Grid B/5

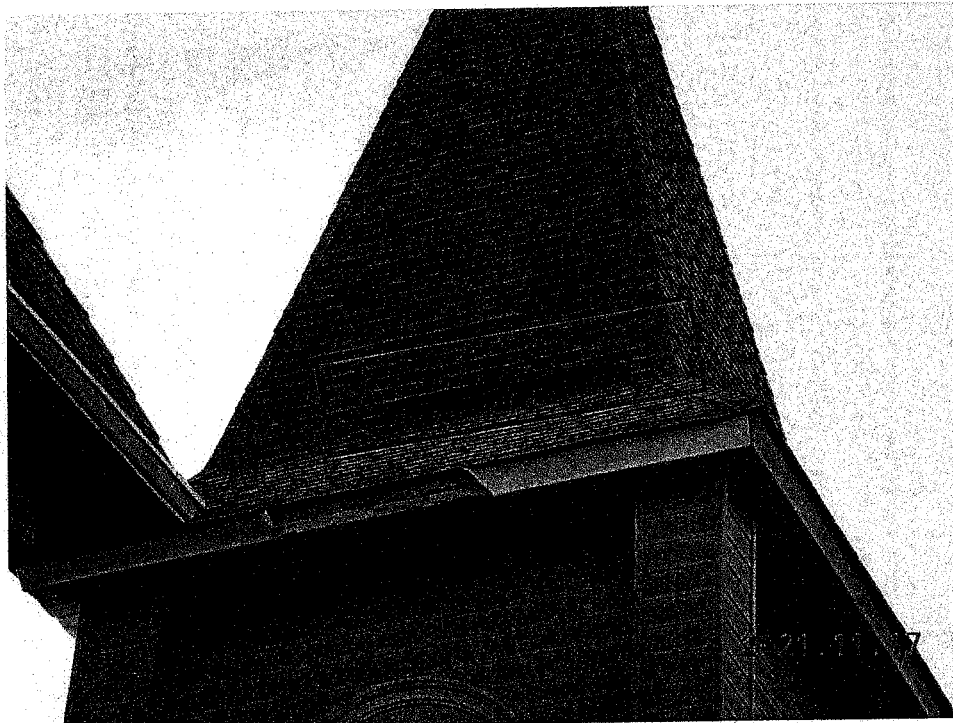
PHOTO NO. 1.46: Routine Repair 21 – Missing roof shingles with exposed and deteriorated timber roof planks. Note: open hole in roof resulting in active water infiltration – Roof, Grid A-B/6-7

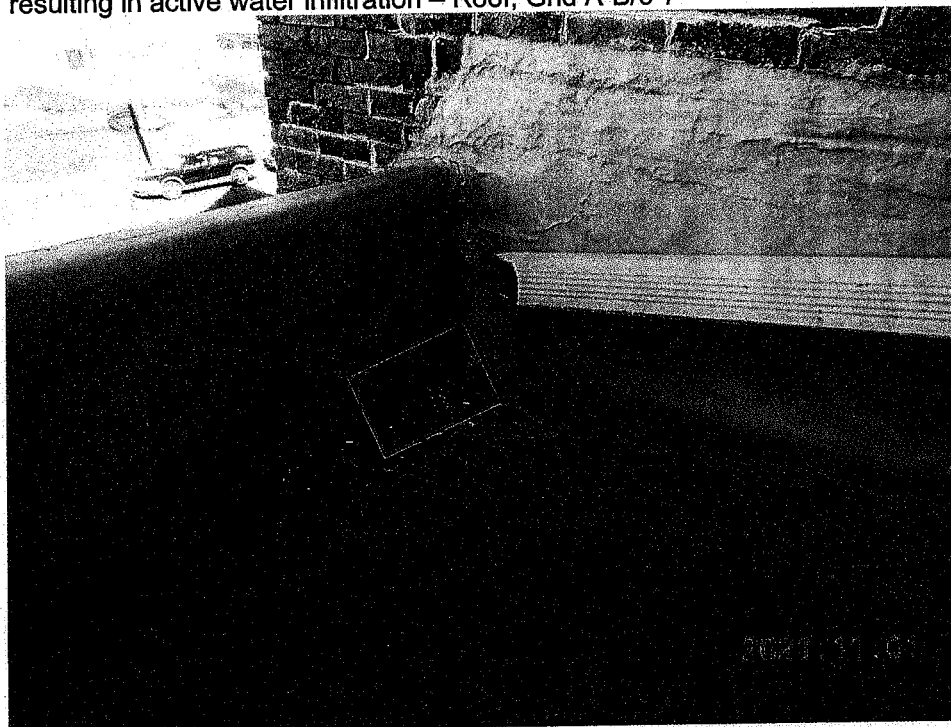
PHOTO NO. 1.47: Routine Repair 22 – Clogged and undersized emergency scuppers. Note: debris cleared during inspection prior to photo being taken – Roof, Grid A/5

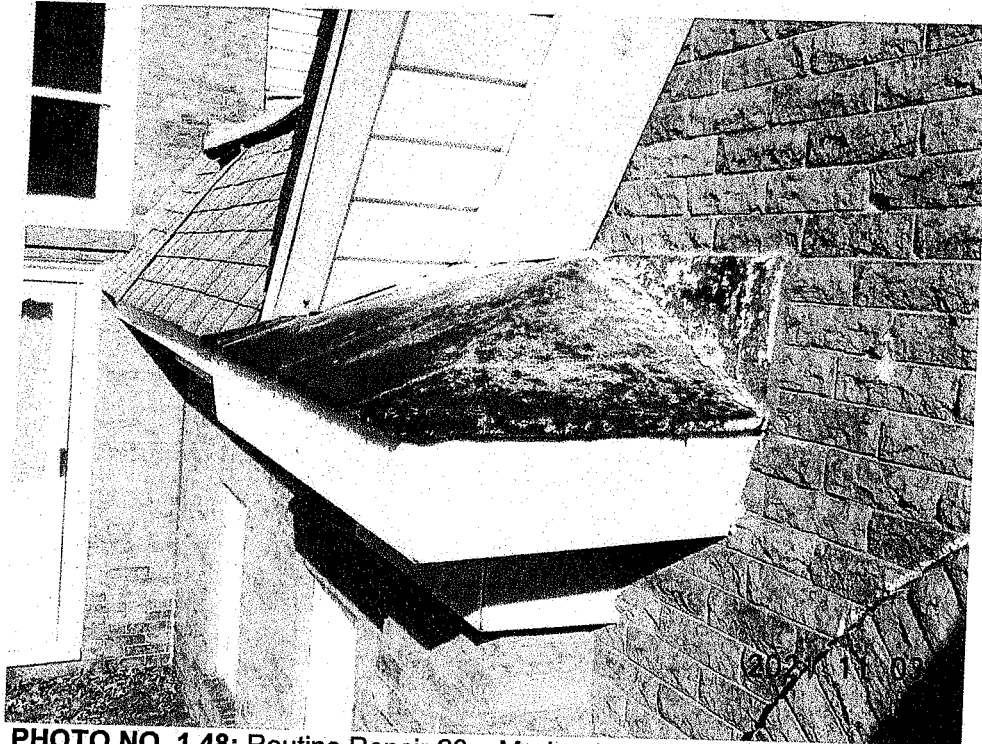
PHOTO NO. 1.48: Routine Repair 23 – Moderate corrosion of sheet metal roof gable end returns with section loss – West Elevation, Grid G: Ht. 15' +/-

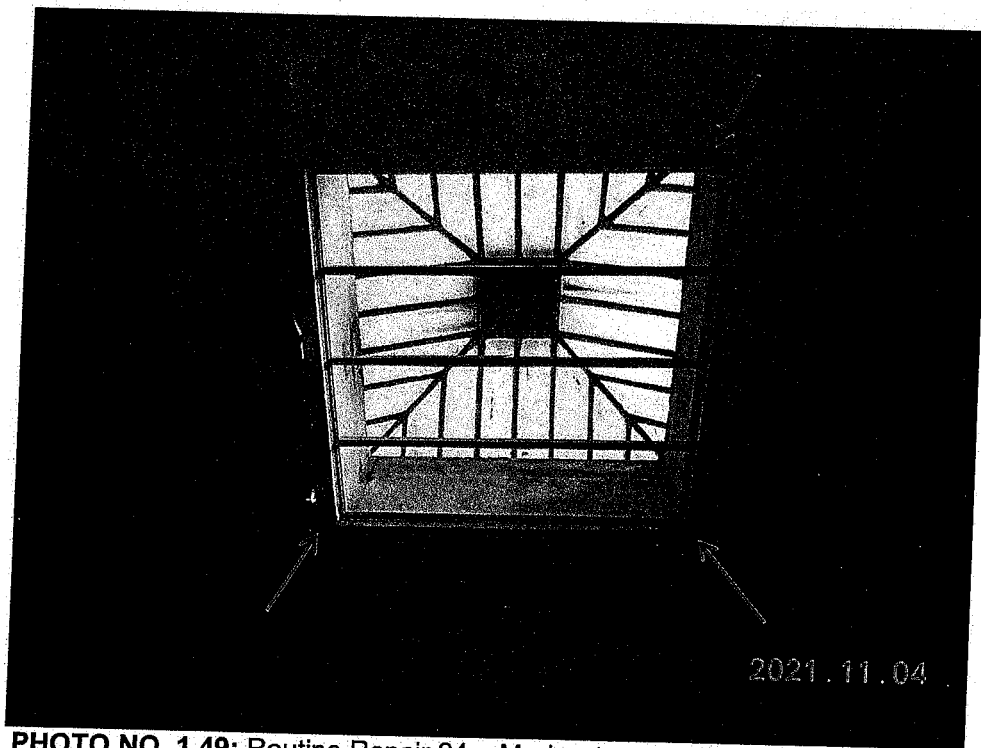
PHOTO NO. 1.49: Routine Repair 24 – Moderate corrosion of steel skylight frame with deteriorated sealant resulting in water infiltration– Roof, Grid G/3-4

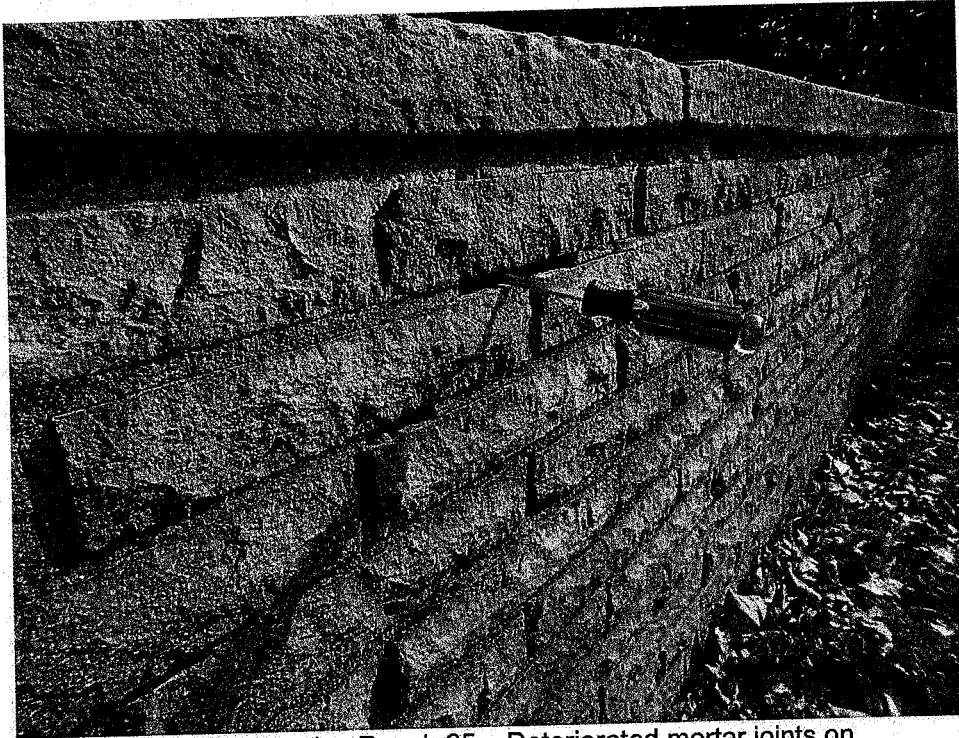
PHOTO NO. 1.50: Routine Repair 25 – Deteriorated mortar joints on masonry retaining wall – Site, Grid G-1/8

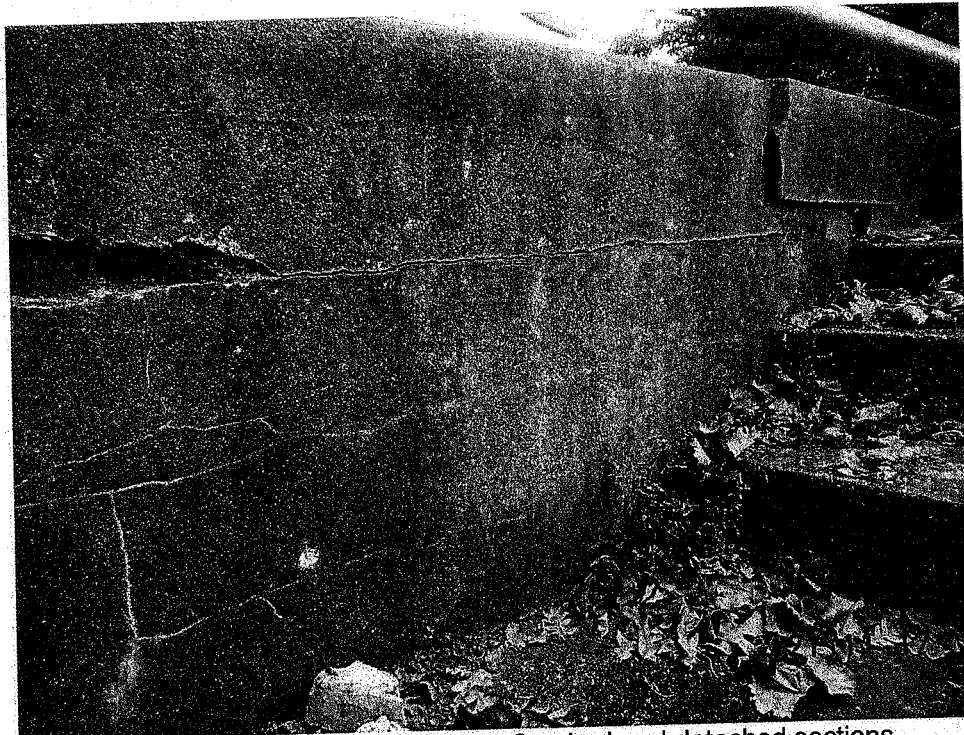
PHOTO NO. 1.51: Routine Repair 26 – Cracked and detached sections of brick masonry retaining wall – Site, Grid A.0-A/3

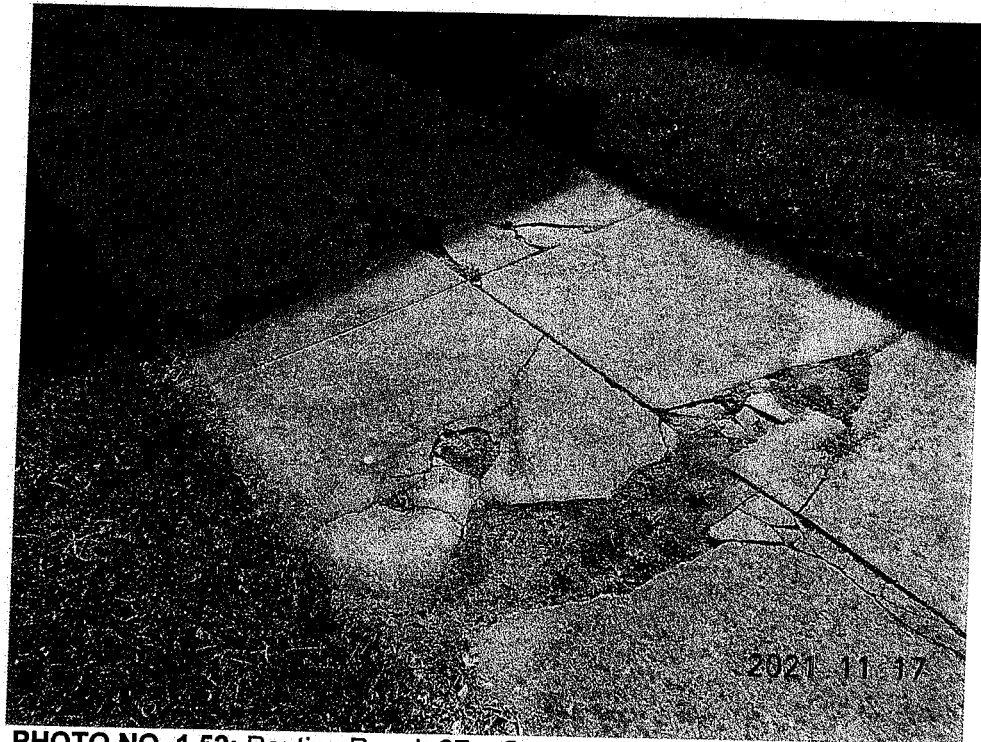
PHOTO NO. 1.52: Routine Repair 27 – Cracked and spalled concrete sidewalk – Site, Grid F-G/6-8

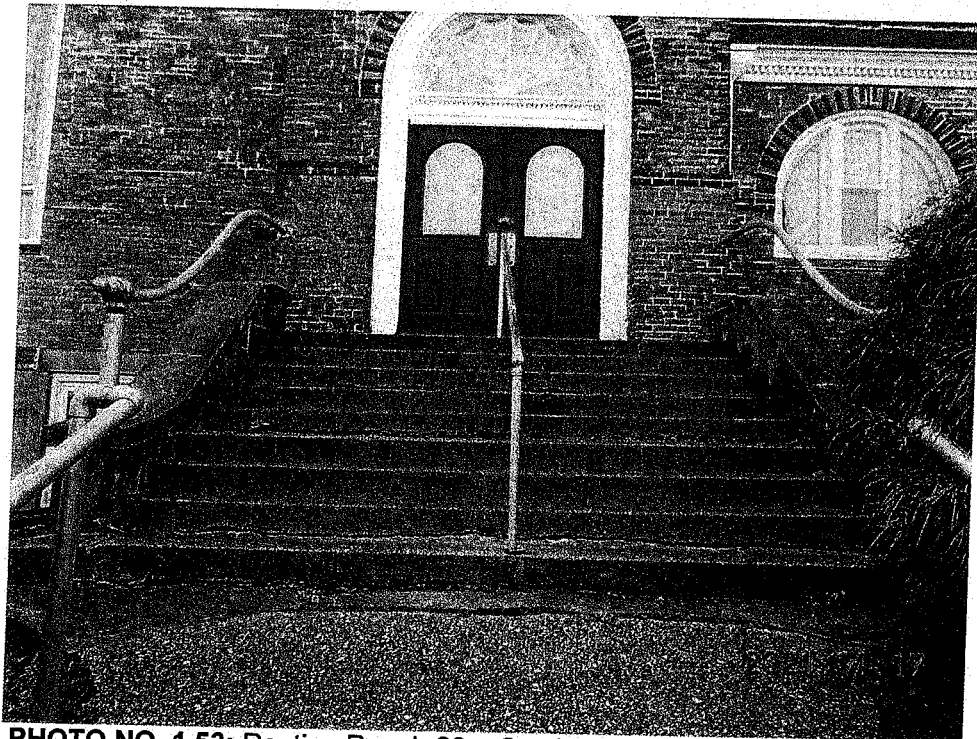
PHOTO NO. 1.53: Routine Repair 28 – Cracked and detached concrete stair treads – Site, Grid A.0-A/4-5

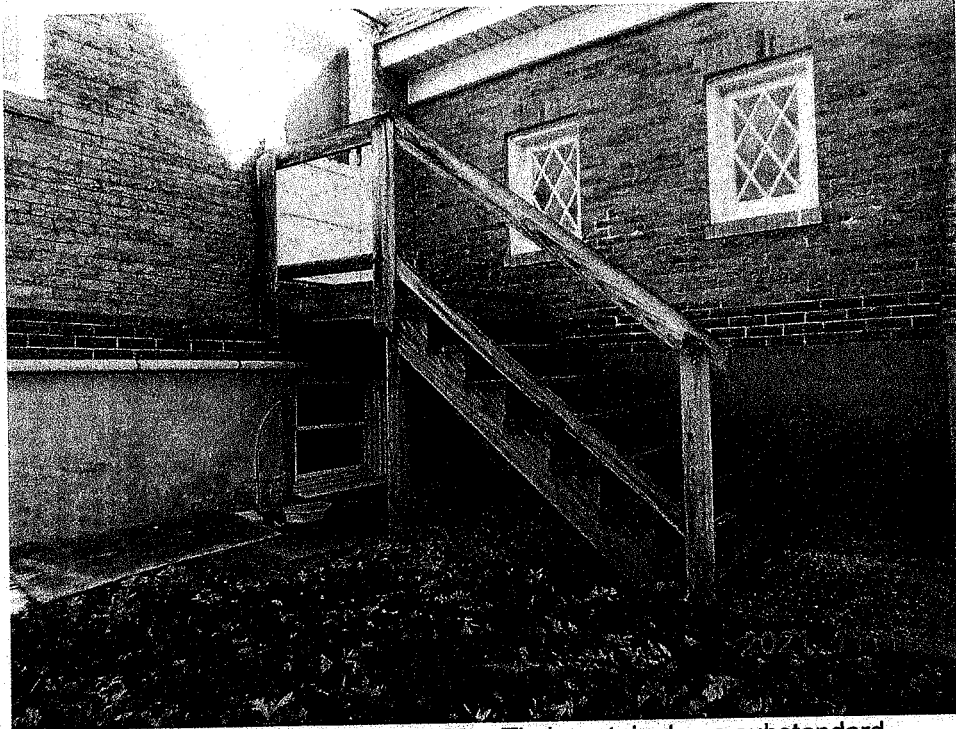
PHOTO NO. 1.54: Routine Repair 29 – Timber stairs have substandard guard/handrail – Site, Grid F-G/6

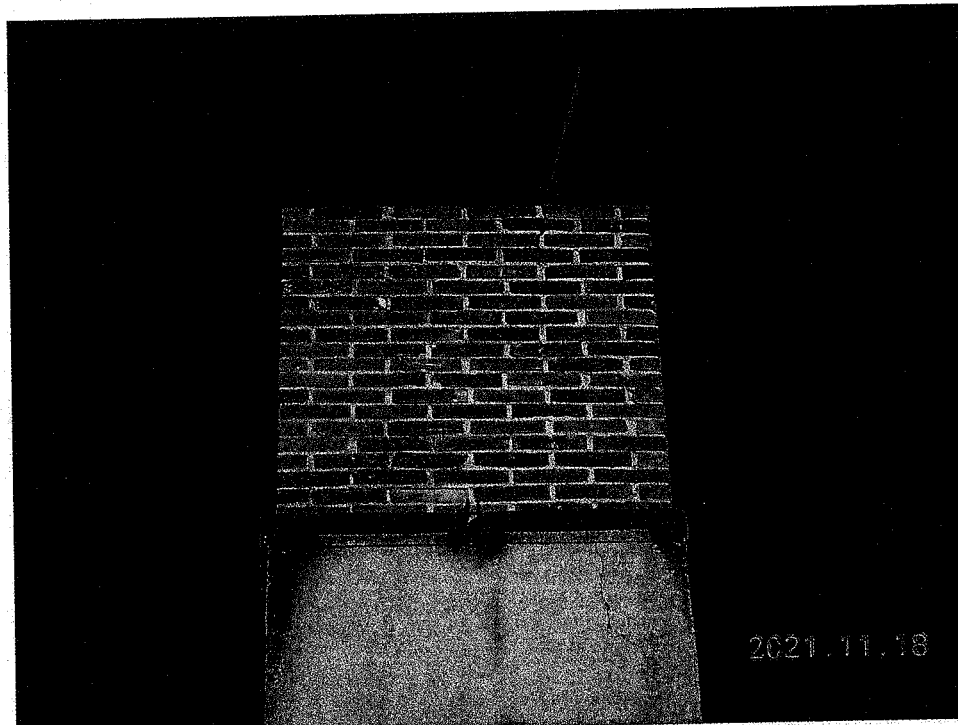
PHOTO NO. 1.55: Routine Repair 30 – Cracking of mortar joints on brick masonry chimney – Roof, Grid D.5-E/5

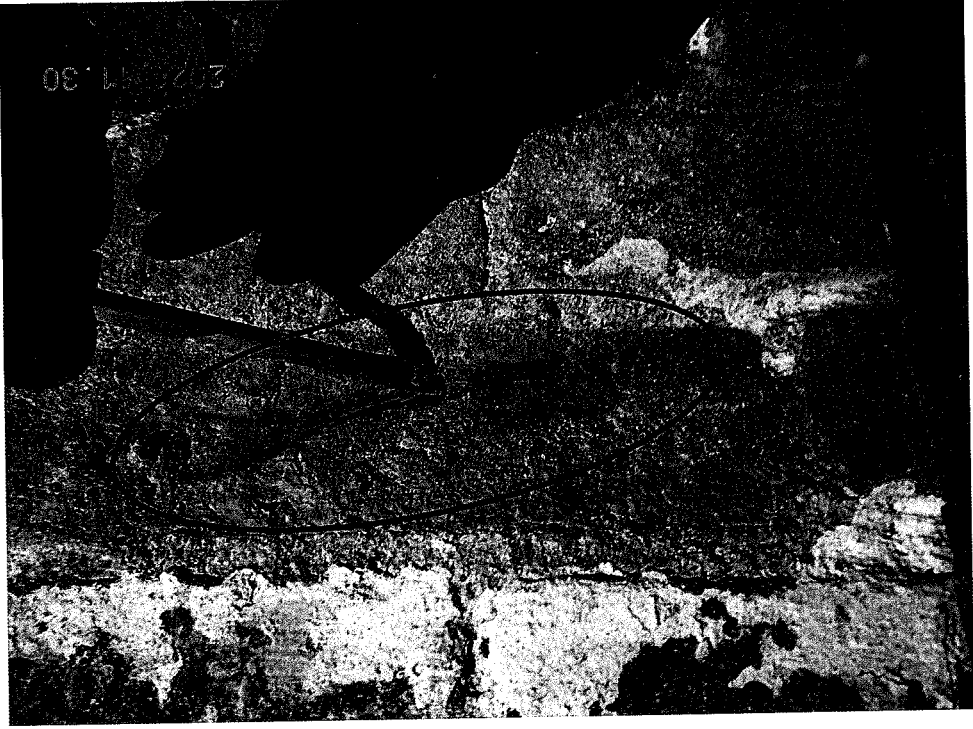
PHOTO NO. C-1: Close-up view at interior face of north foundation wall. Note: grooves carved into brick with flat head screwdriver due to soft condition of brick.

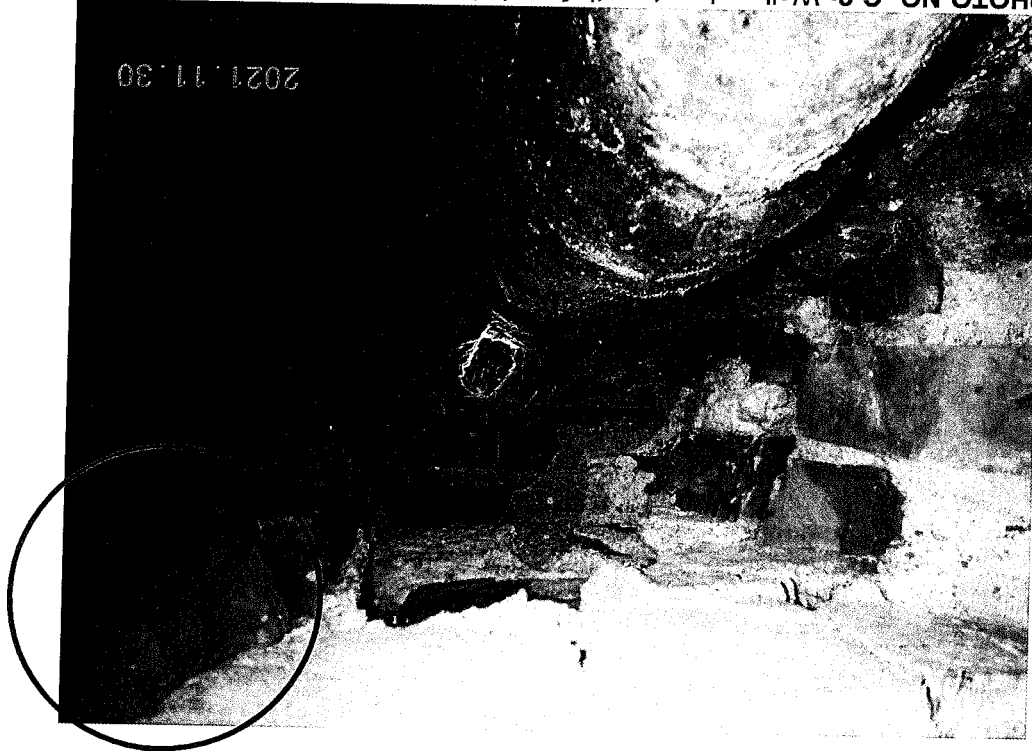
PHOTO NO. C-2: Wall probe at north foundation wall. Note: color stratification in the brick circled above. The core has a different color than the exterior, which is reflective of the inconsistent kiln firing process mentioned above.

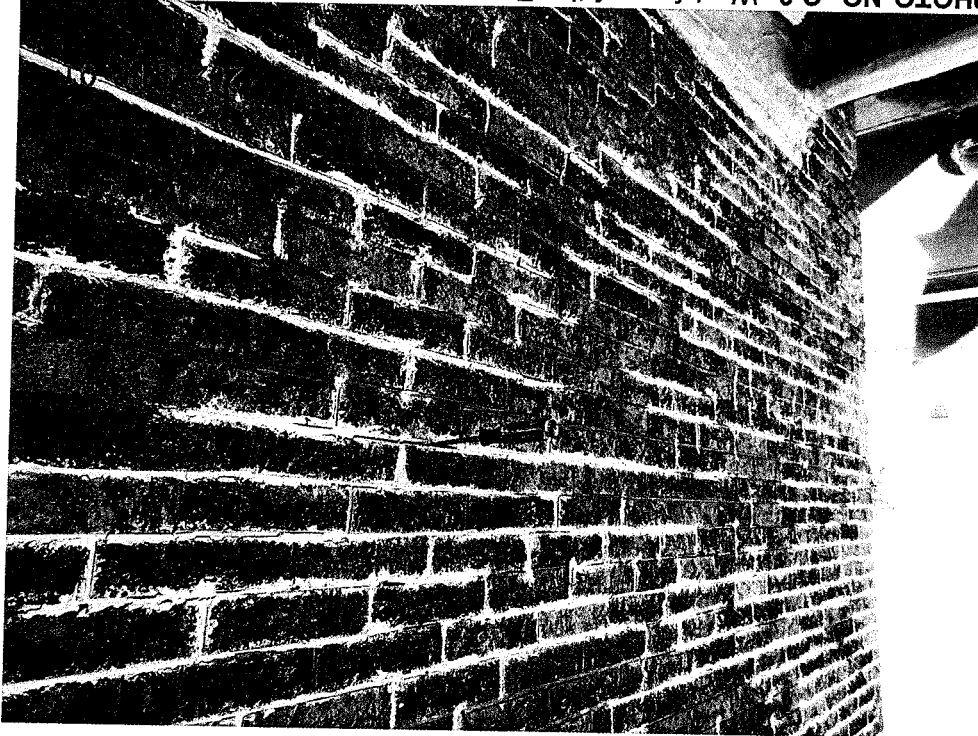
PHOTO NO. C-3: West face of the East Tower. Note: majority of joints filled with white caulk.
